ROUTING COVER SHEET

NON-PROCUREMENT DOCUMENTS ONLY
ROUTE THROUGH DOCUSIGN – NOT ORACLE

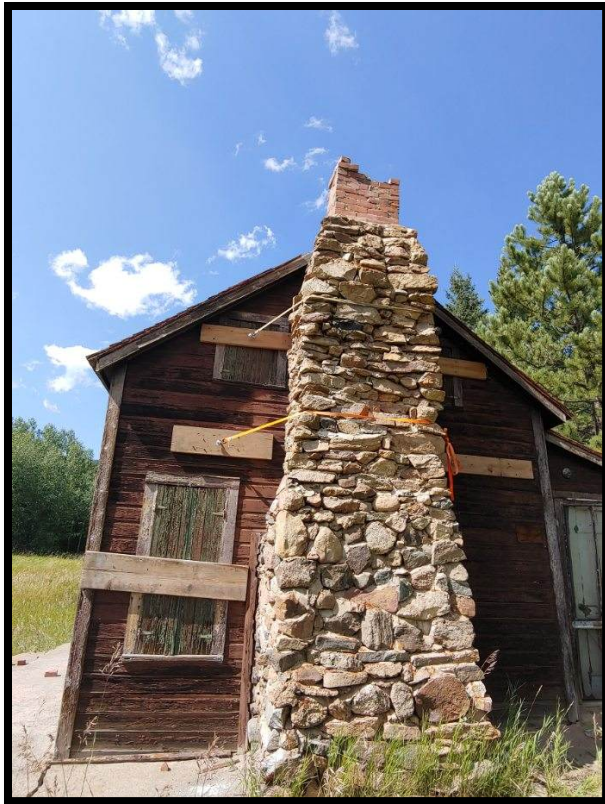
Tucker Cabin – exterior stone chimney with emergency strapping in place to prevent chimney failure

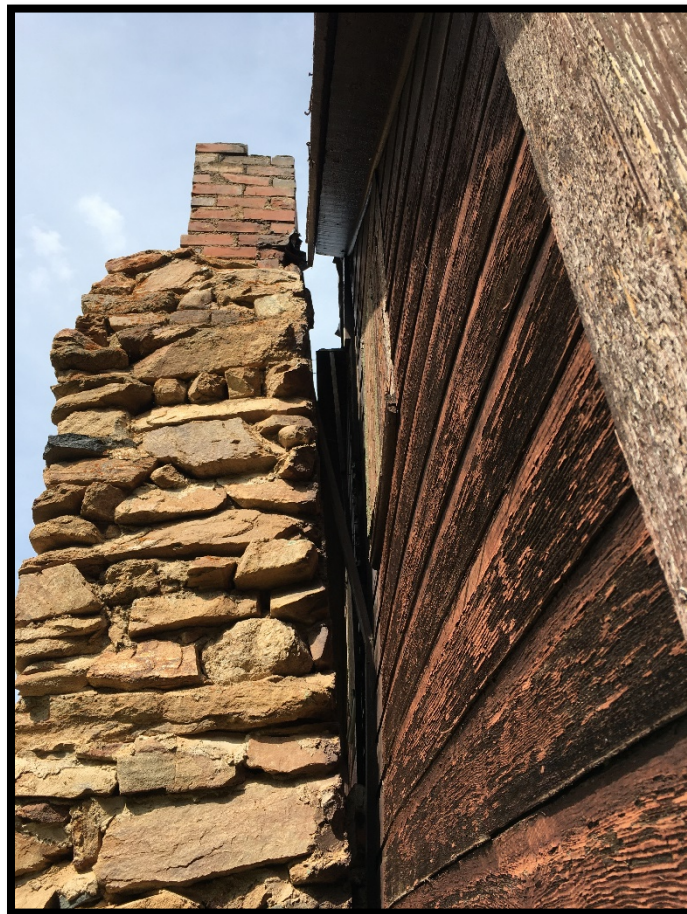
Tucker Cabin – exterior stone chimney detail showing large separation away from building exterior

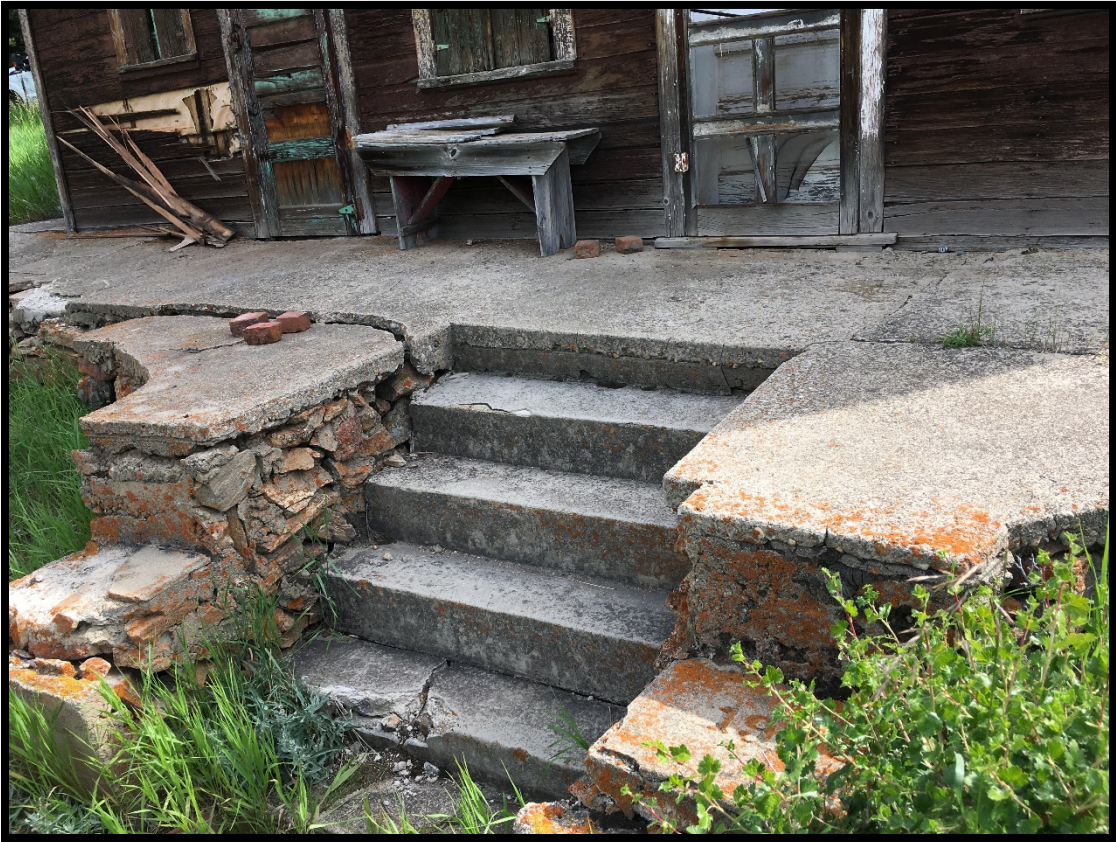
Tucker Cabin – exterior concrete porch detail showing damage with cabin siding damage in background

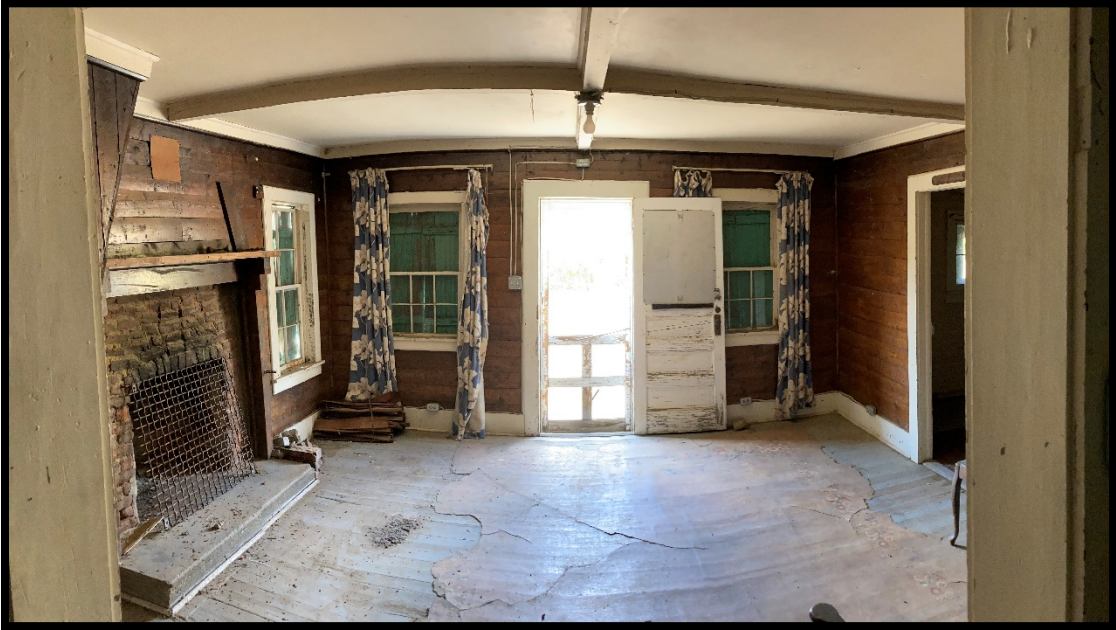
Tucker Cabin – living room overview after interior cleanup and before interior temp wall installed

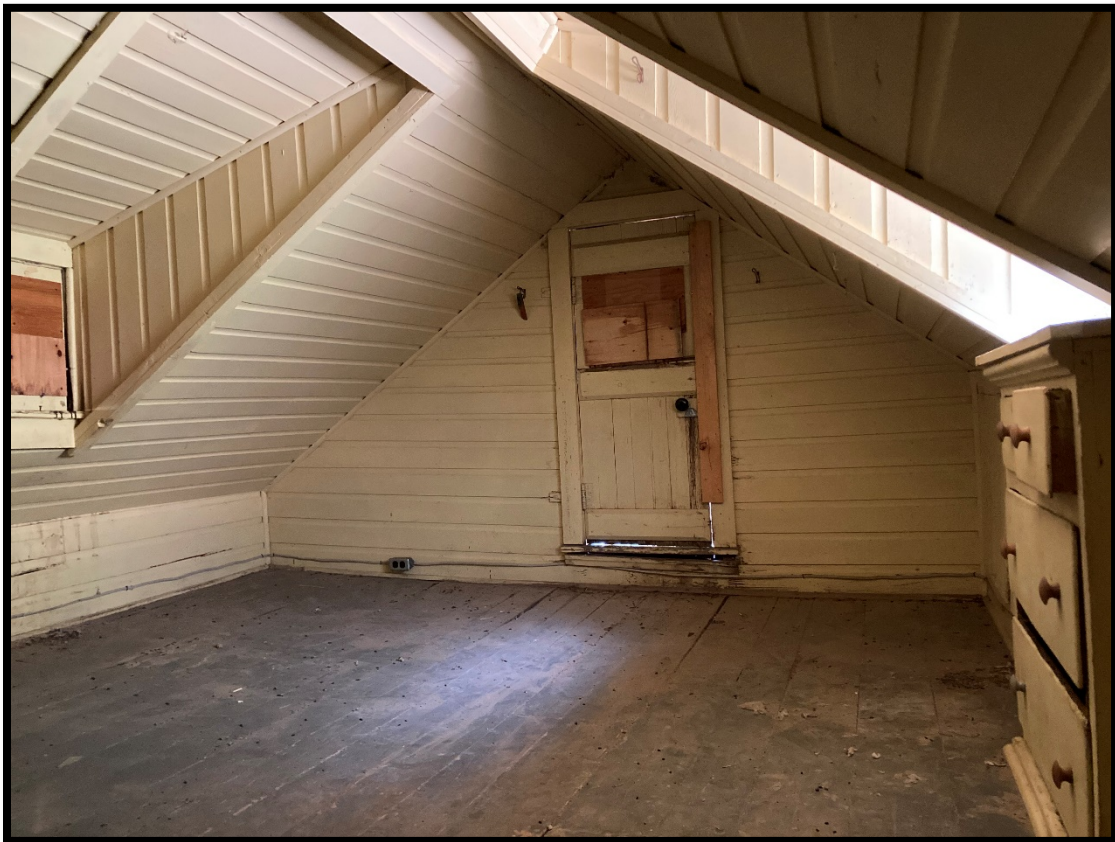
Tucker Cabin – 2nd floor bedroom with sagging unsafe floor after interior cleanup

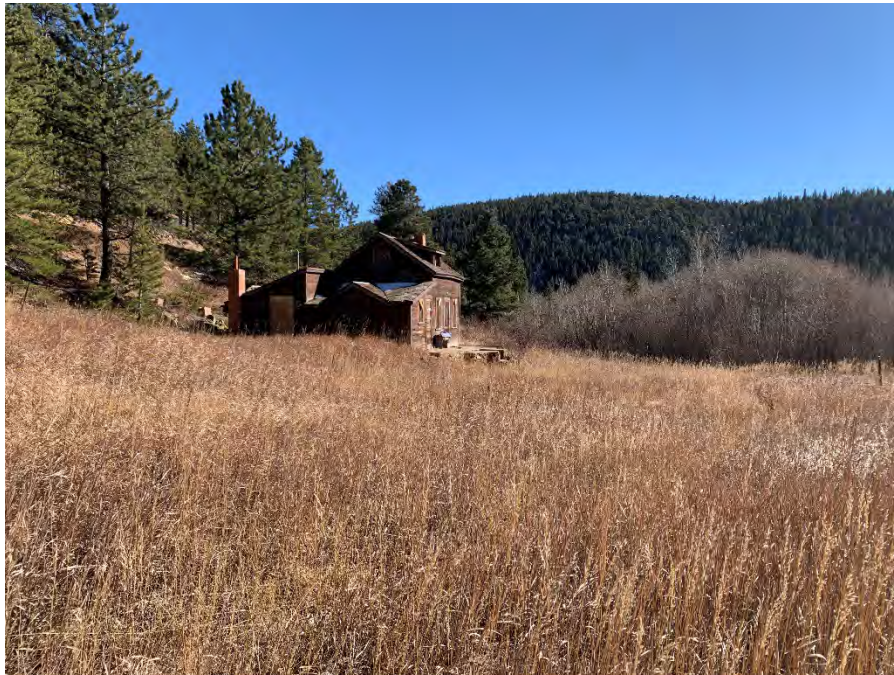
Figure 6: Overall view of the site to the north and west of the building.

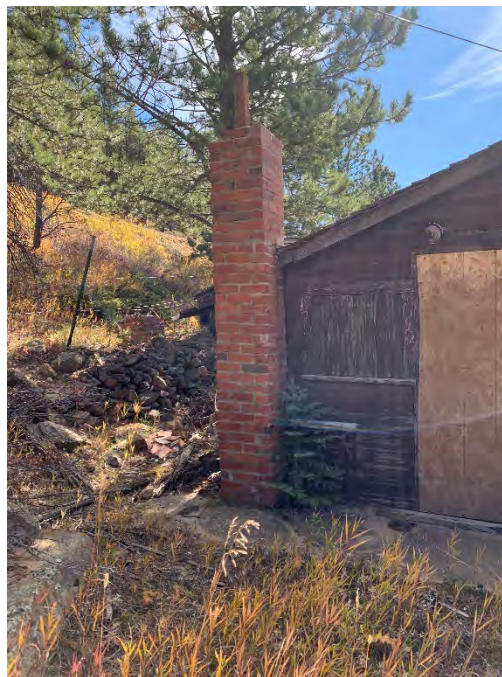
Figure 18: Site slope to the east of the building.

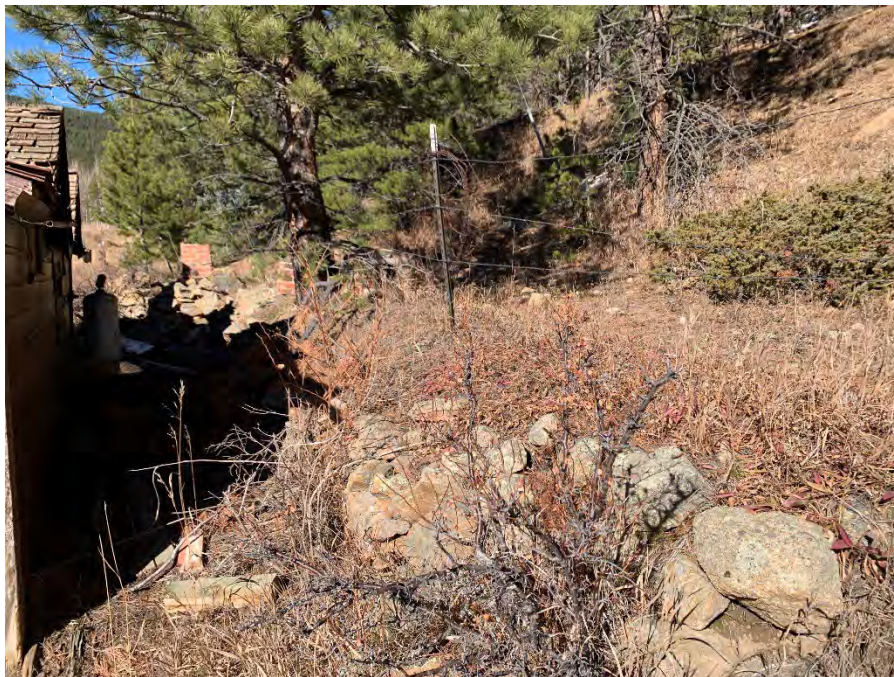
Figure 21: Historic driveway area located to the east of the cabin.

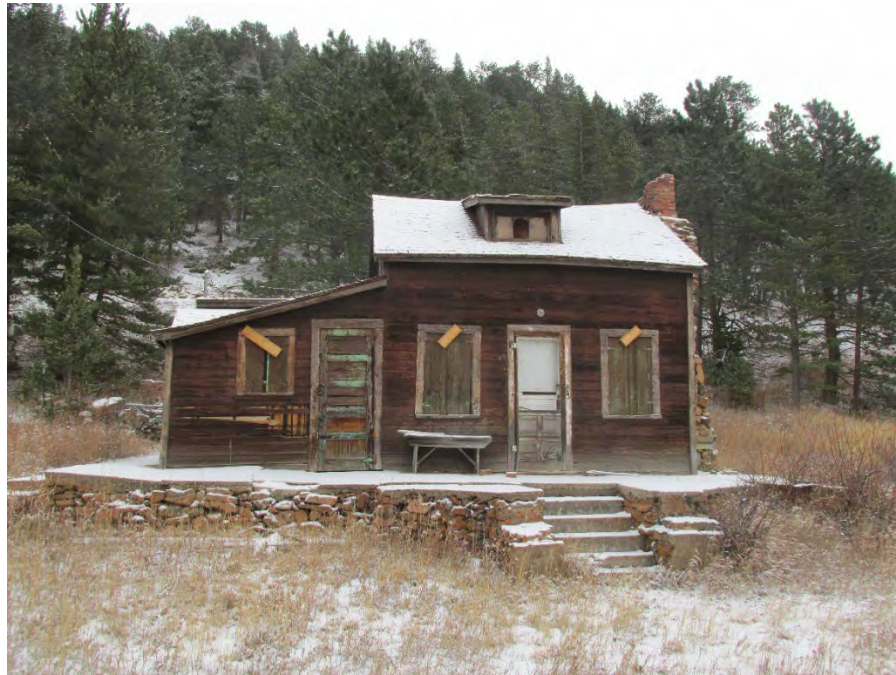
Figure 23: Front (west) elevation of Tucker Ranch cabin.

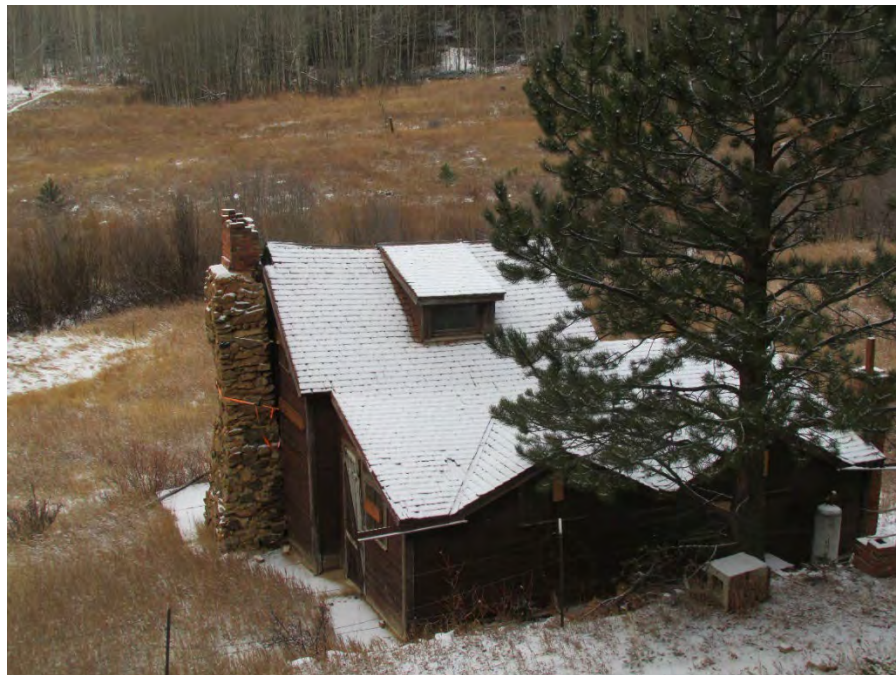
Figure 24: Tucker Ranch cabin looking west-northwest.

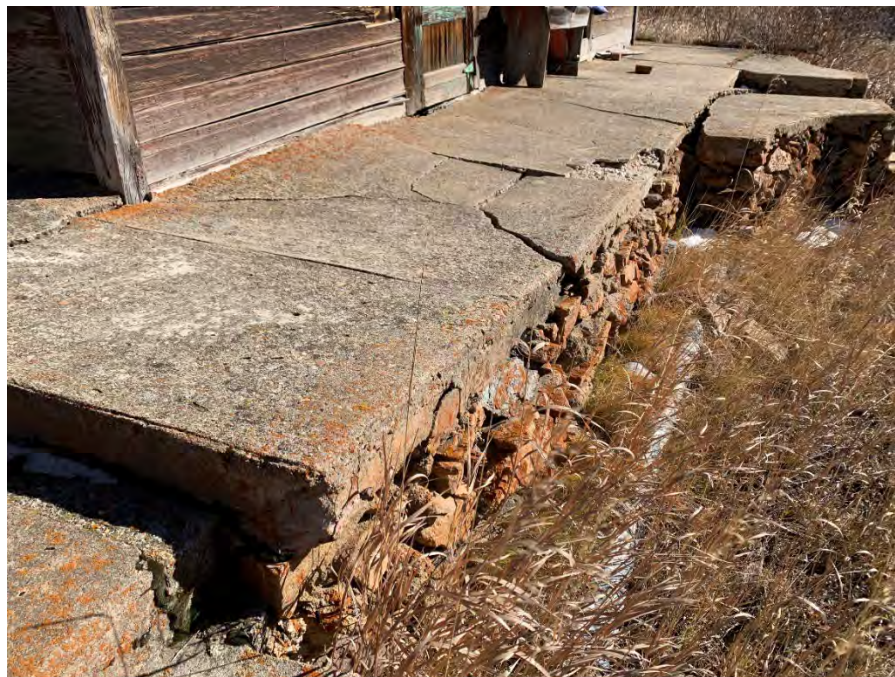
Figure 25: Rubble masonry platform and concrete topping at west elevation

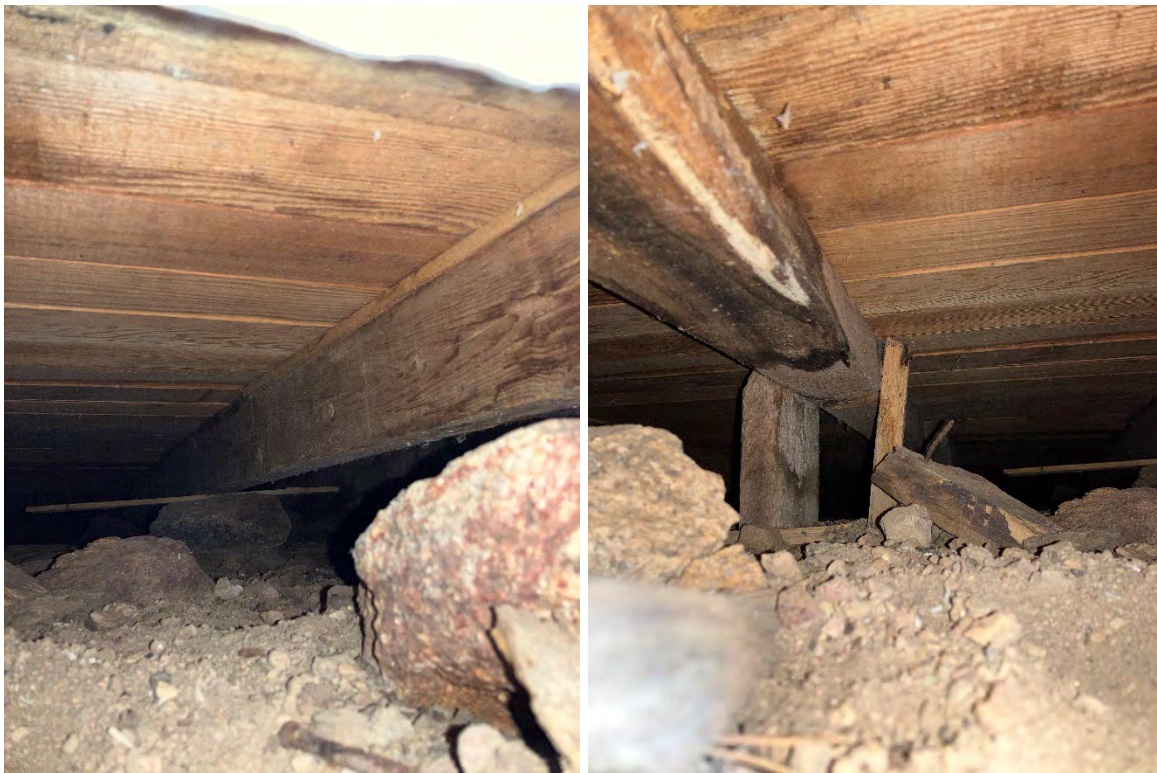
Figure 26: Examples of first floor framing as seen from a small opening on the west elevation. Note the sporadically placed stone and wood props, and the water staining visible on some of the joists.

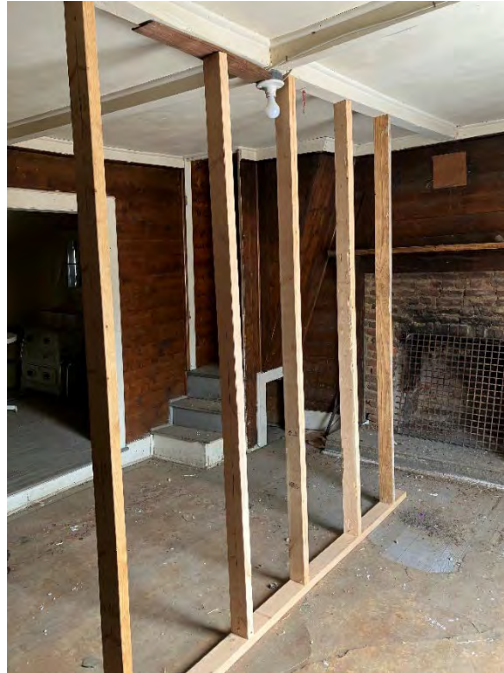
Figure 27: Temporary stud shoring wall supporting second floor framing above

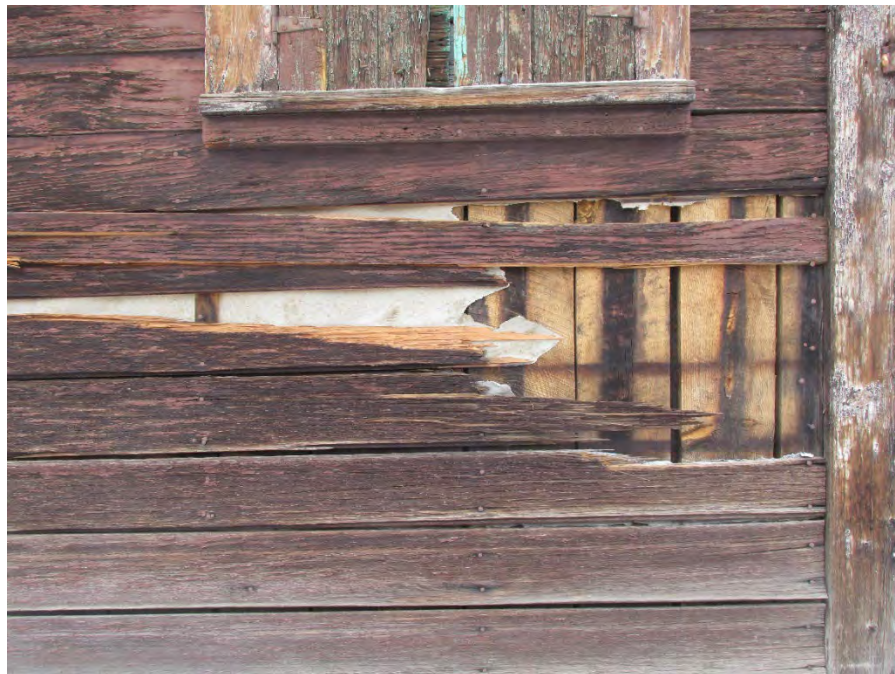
Figure 29: Exterior wall, area of missing siding. Note 2 layers of 1x sheathing.

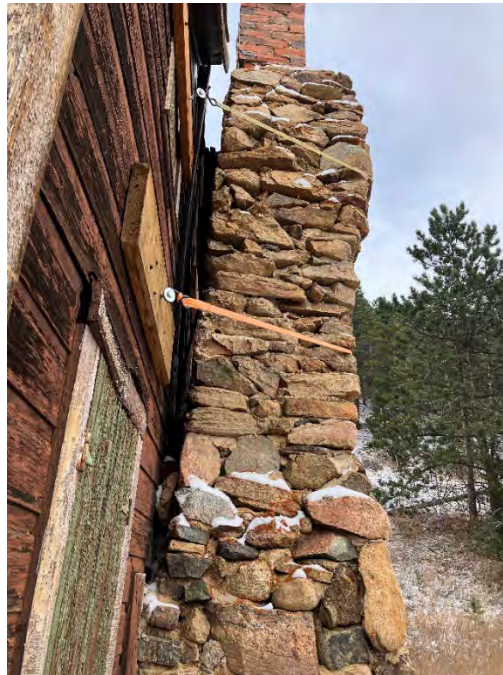
Figure 30: Stone chimney strapped to south elevation of the cabin. Note gap between cabin and chimney widens along the height indicating outward lean.

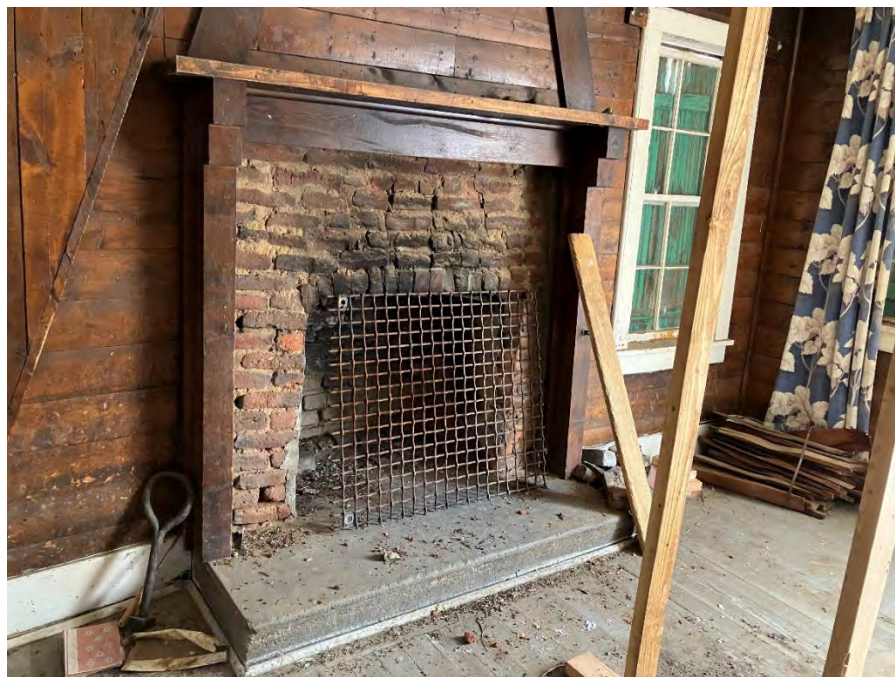
Figure 31: Brick fireplace of the south chimney, note arch-shaped cracks above shallow arch

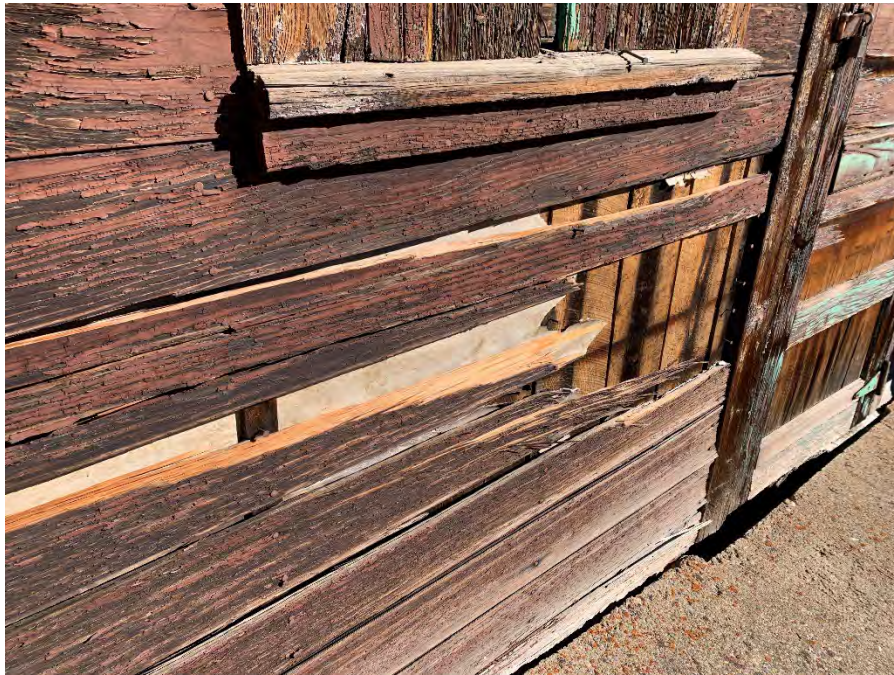
Figure 32: Painted wood siding on the west elevation. Note area of damage will require replacement.

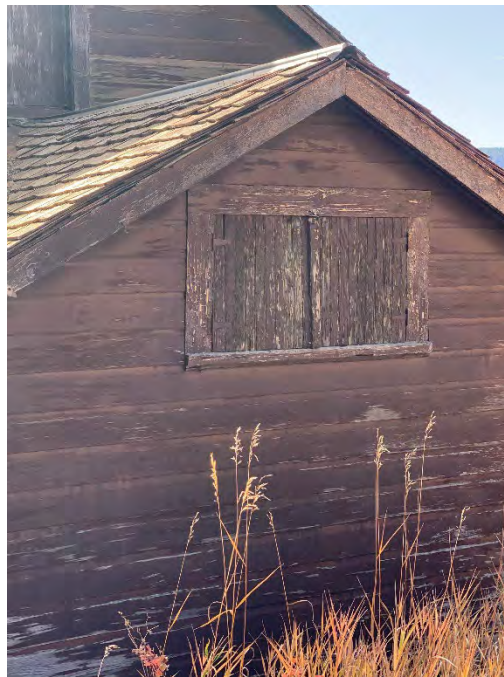
Figure 33: Typical exterior wood siding and trim.

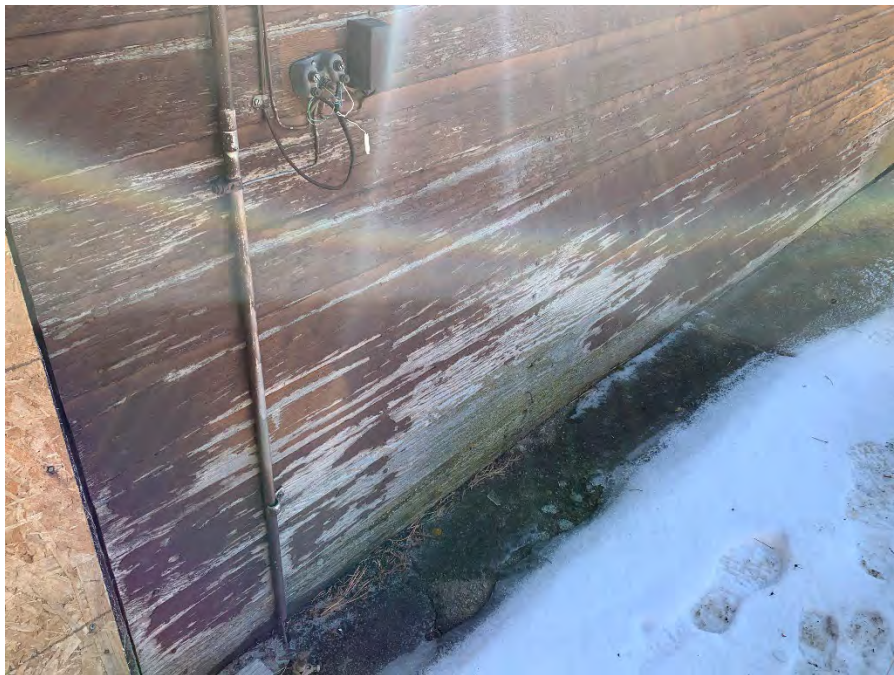
Figure 35: Deterioration typical at the lower section of the exterior walls

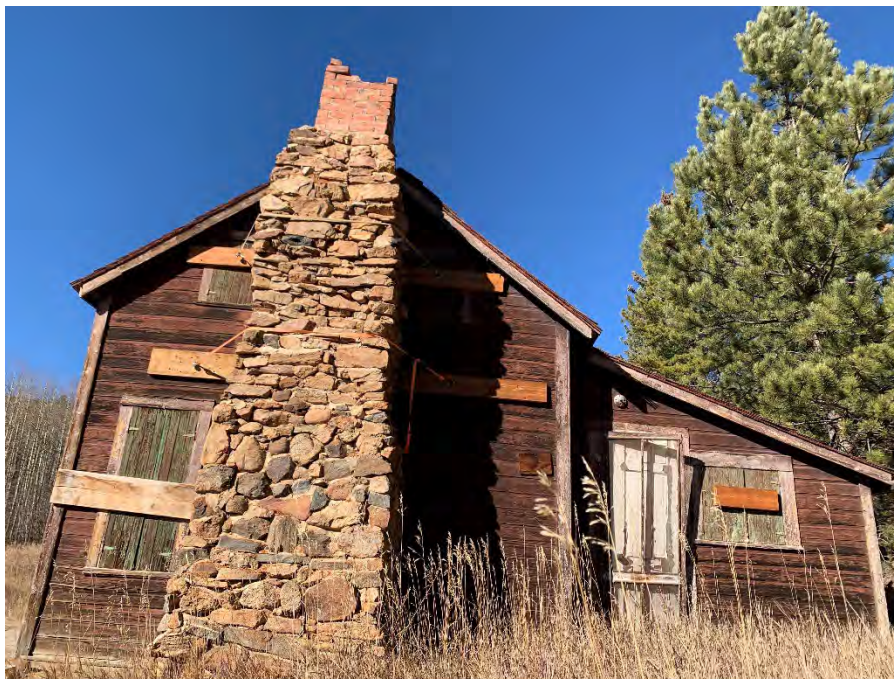
Figure 36: Overall view of masonry chimney on the south elevation of the cabin.

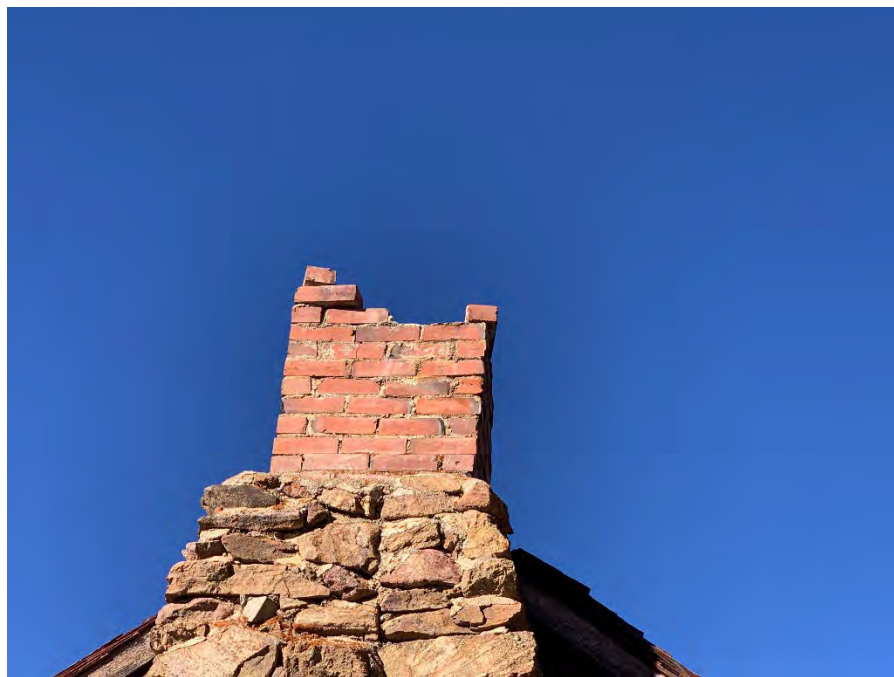
Figure 38: Detail view of brick condition at the top of the south elevation chimney.

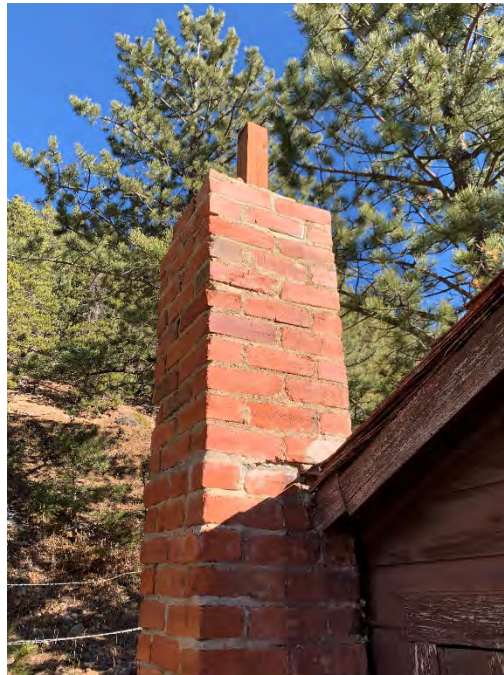
Figure 39: Brick chimney located to the northeast of the building.

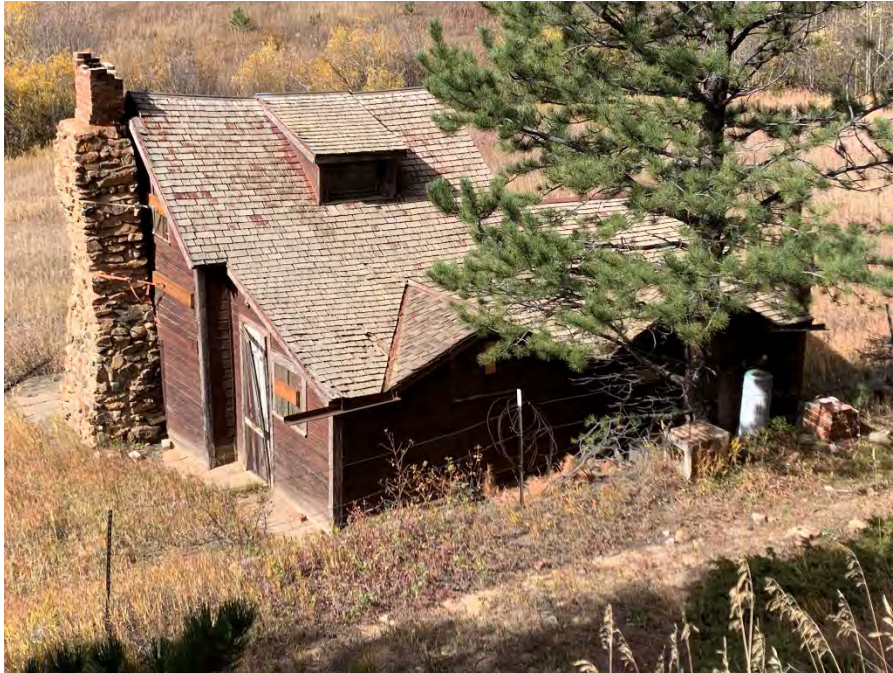
Figure 41: Overall view of the east side of the cabin roof.

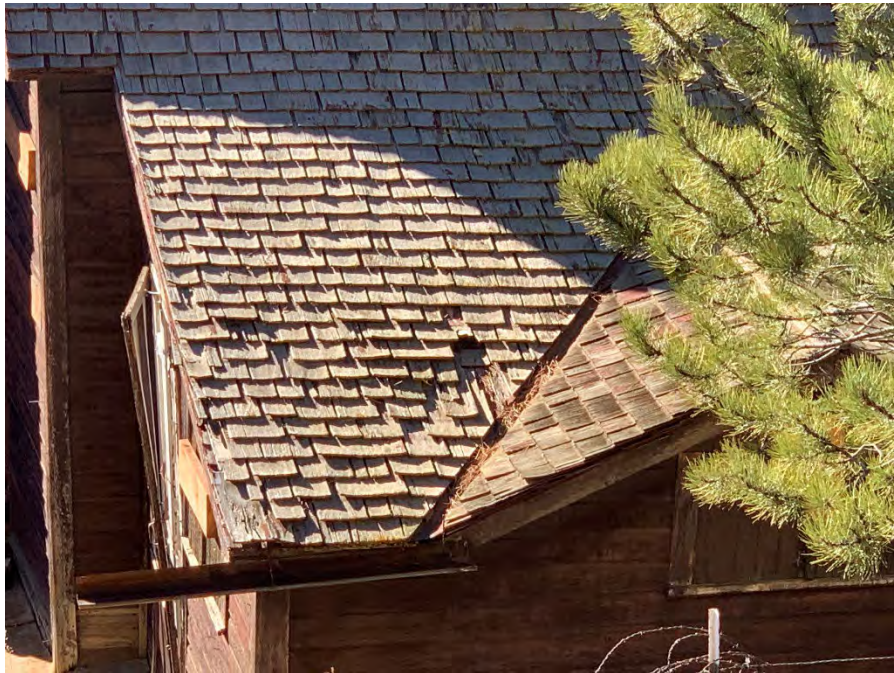
Figure 43: Detail view of missing shingles on the east slope of the roof.

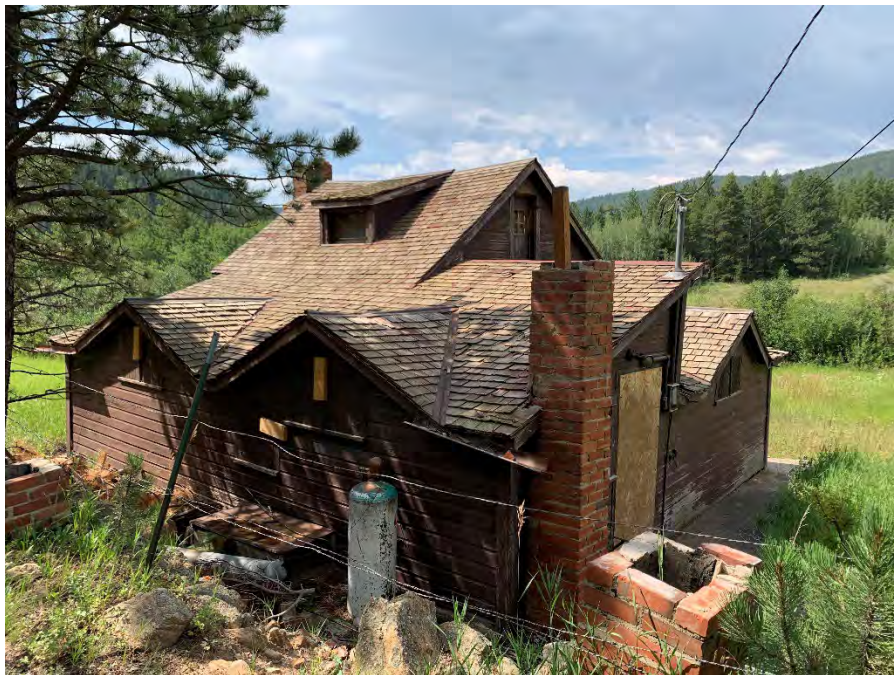
Figure 44: Roof from the northeast corner of the building. Note area of damage on the gable dormer and ridge cap due to the chimney failure.

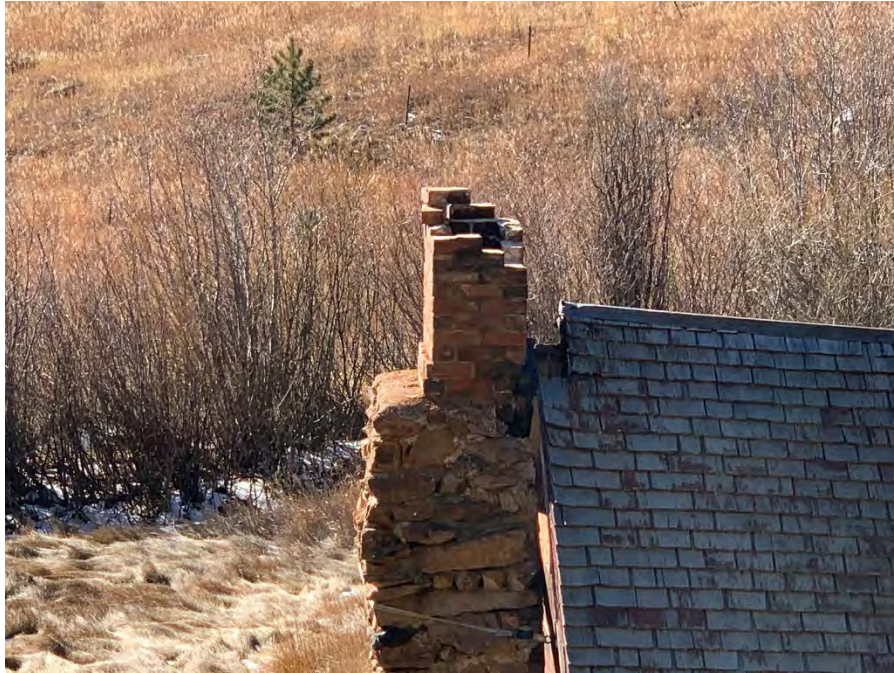
Figure 45: Detail view of roof condition adjacent to the south chimney.

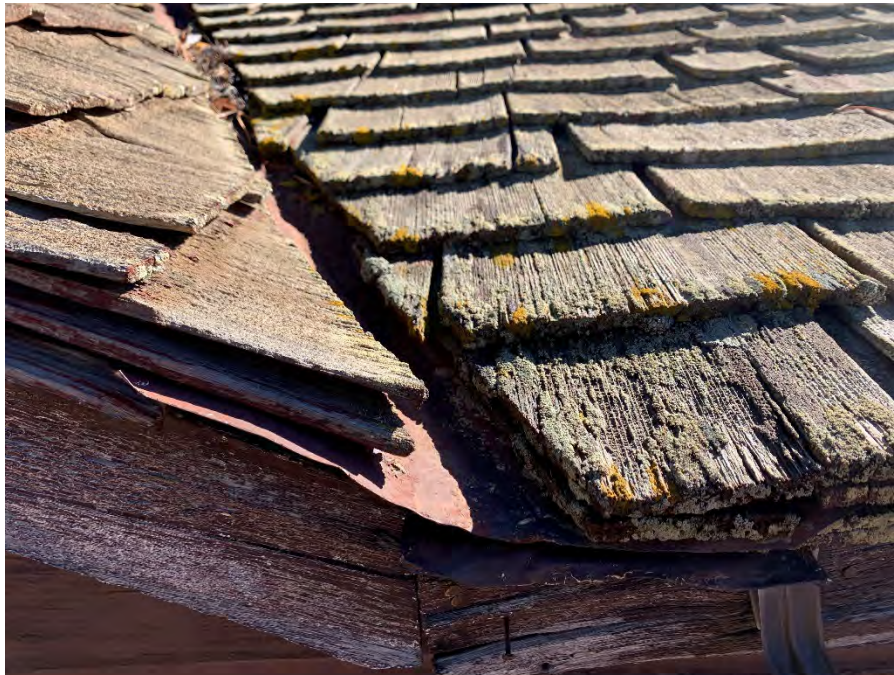
Figure 46: Detail view of sheet metal valley flashing.

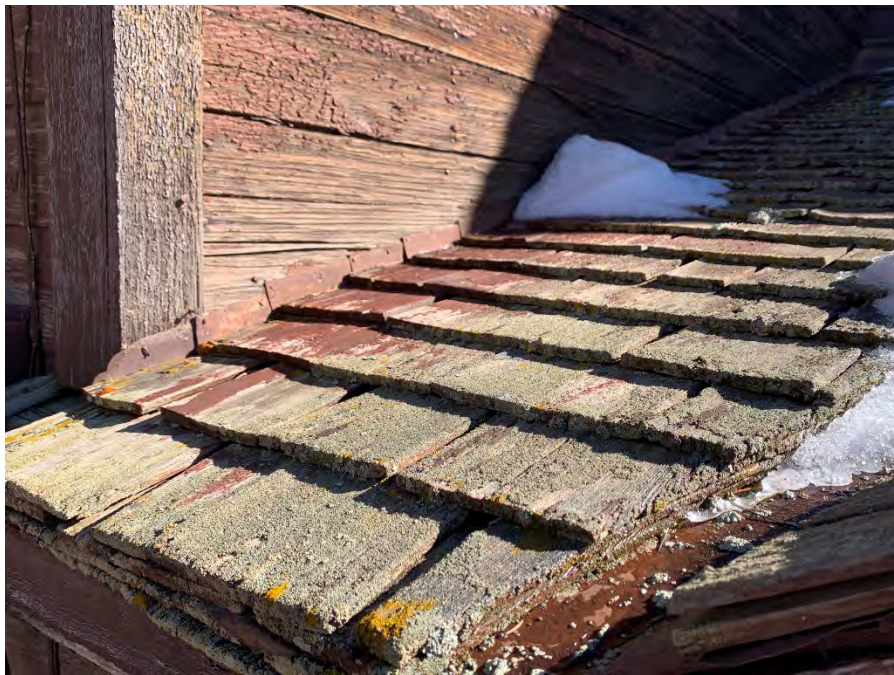
Figure 47: Detail view of flashing at roof to wall transition.

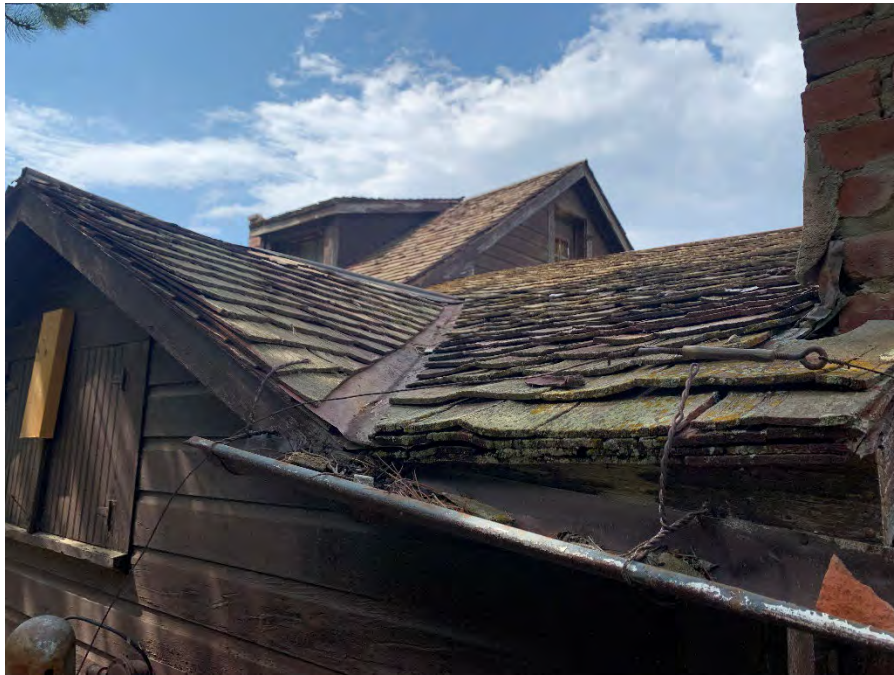
Figure 48: Half round gutter at the north end of the east elevation.

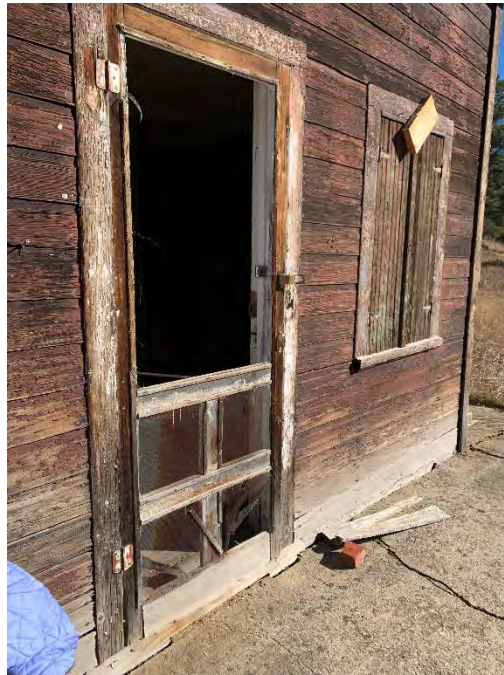
Figure 50: Exterior screen door at the main entrance on the west elevation.

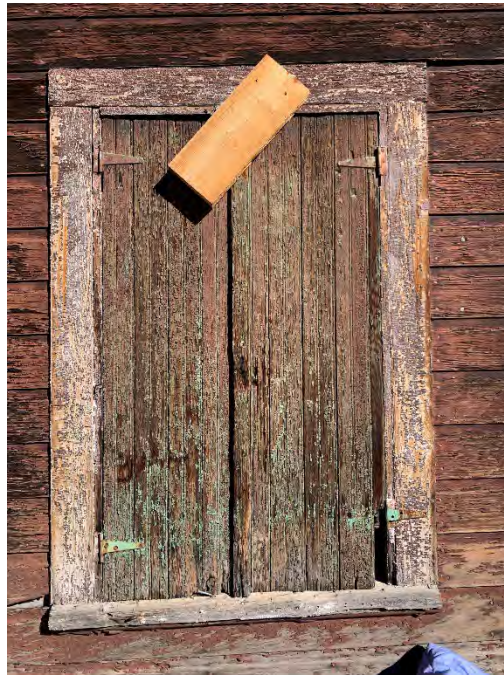
Figure 58: Exterior view of typical shutters.

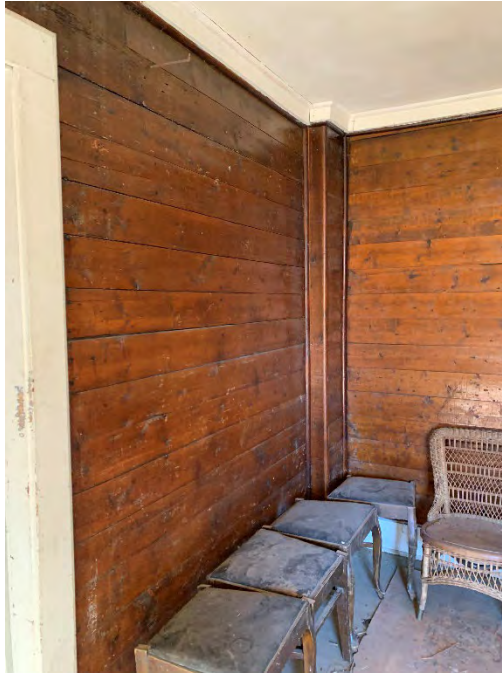
Figure 72: Horizontal wood plank wall finish in the first floor living room.

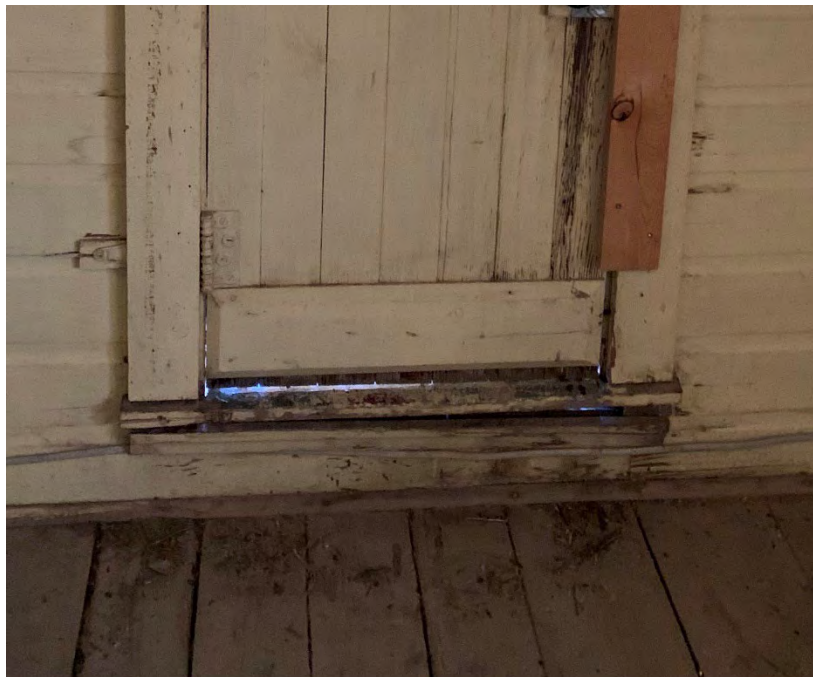
Figure 79: Water damage below the threshold at the second floor door opening.

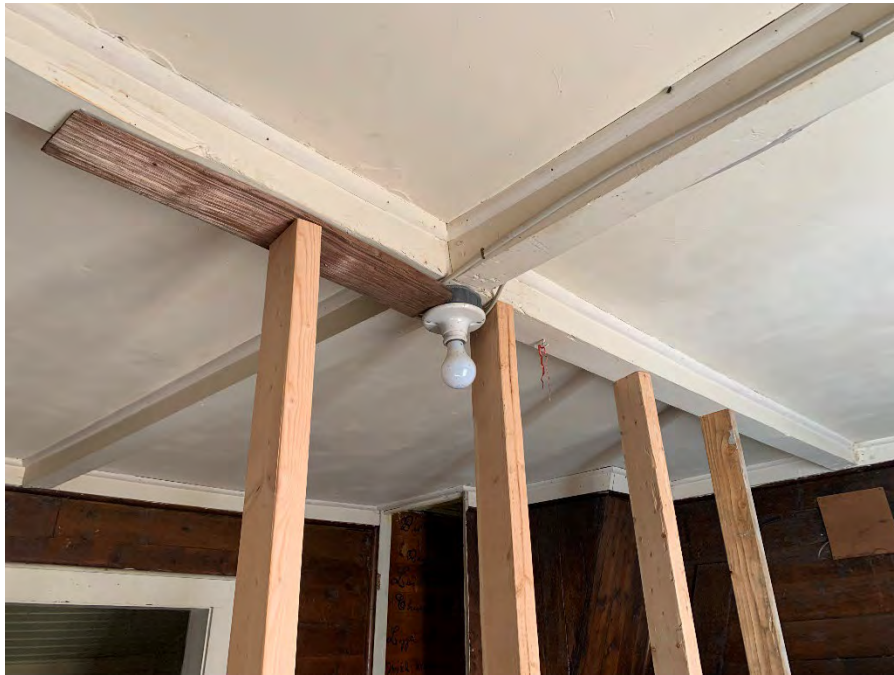
Figure 80: Overall view of ceiling finish in the living room.

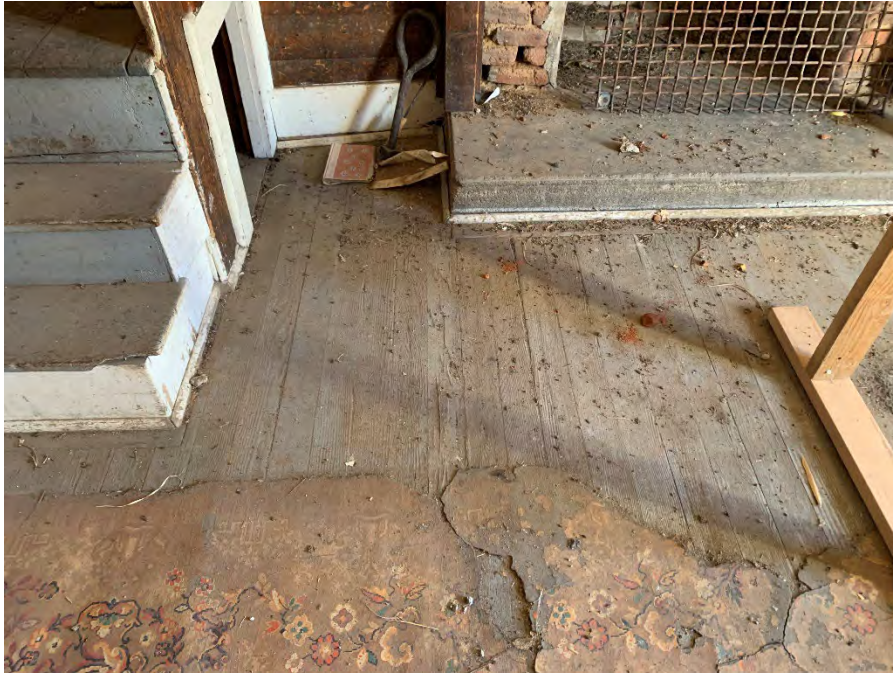
Figure 83: Painted wood flooring typical throughout the first floor. Note linoleum 'rug' visible in the lower section of the photo.

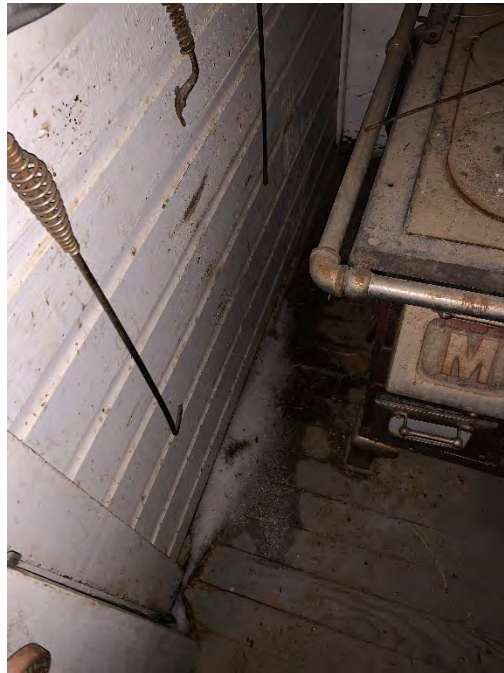
Figure 86: Snow observed in the kitchen.

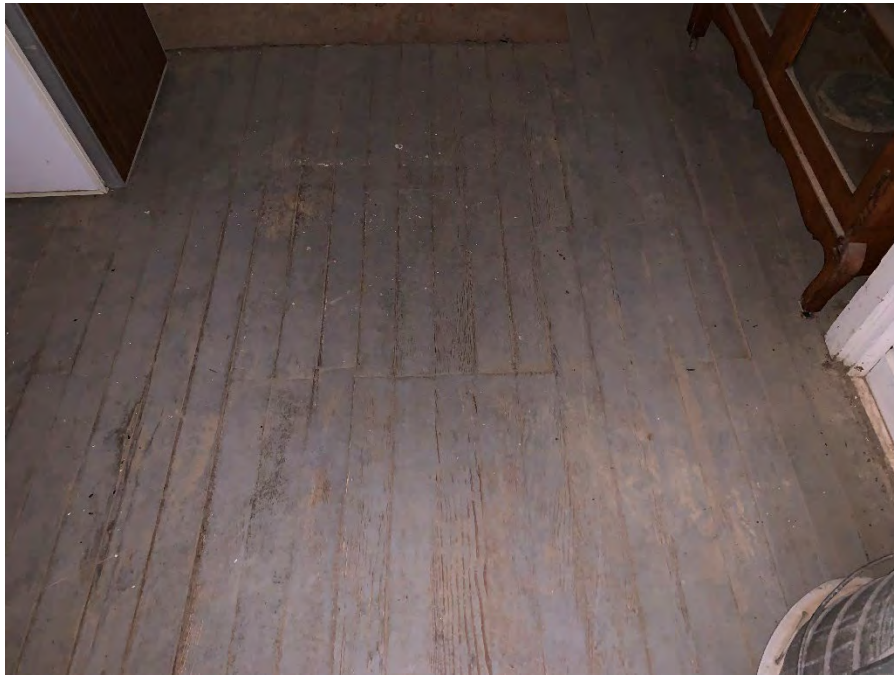
Figure 87: Joint noted in kitchen flooring.

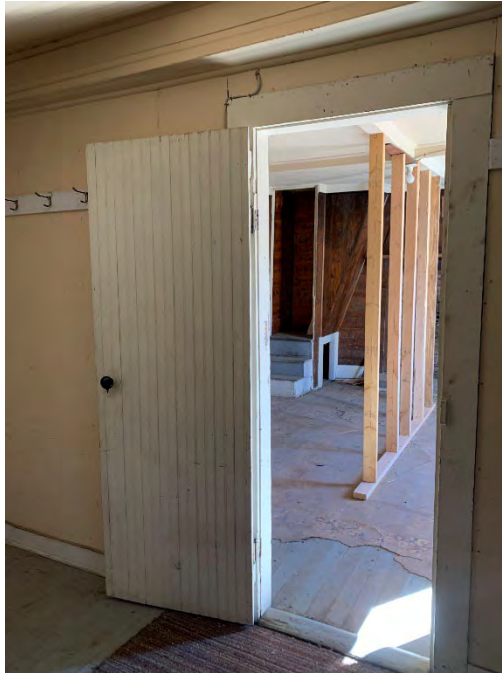
Figure 88: Door located between the first floor bedroom and the living room.

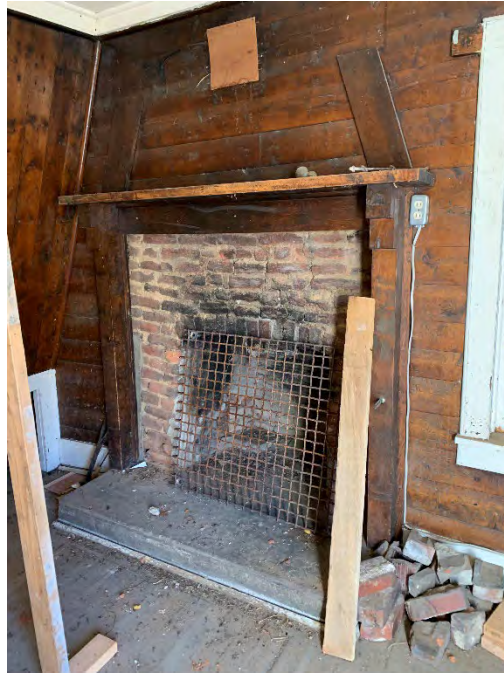
Figure 92: Overall view of fireplace located in the south wall of the living room.

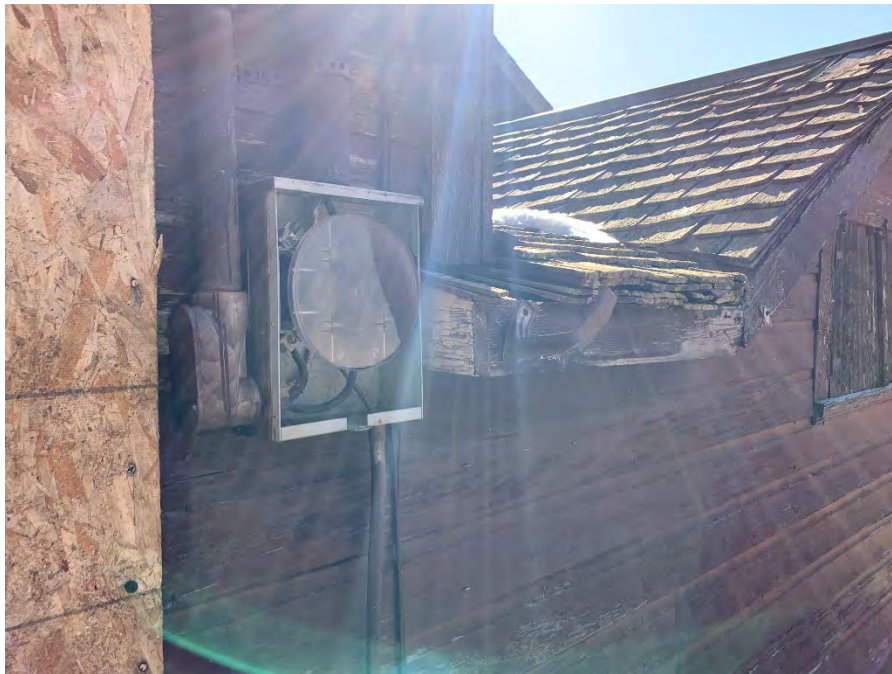
Figure 98: Electrical service equipment on the north elevation.
