ROUTING COVER SHEET

NON-PROCUREMENT DOCUMENTS ONLY
ROUTE THROUGH DOCUSIGN – NOT ORACLE

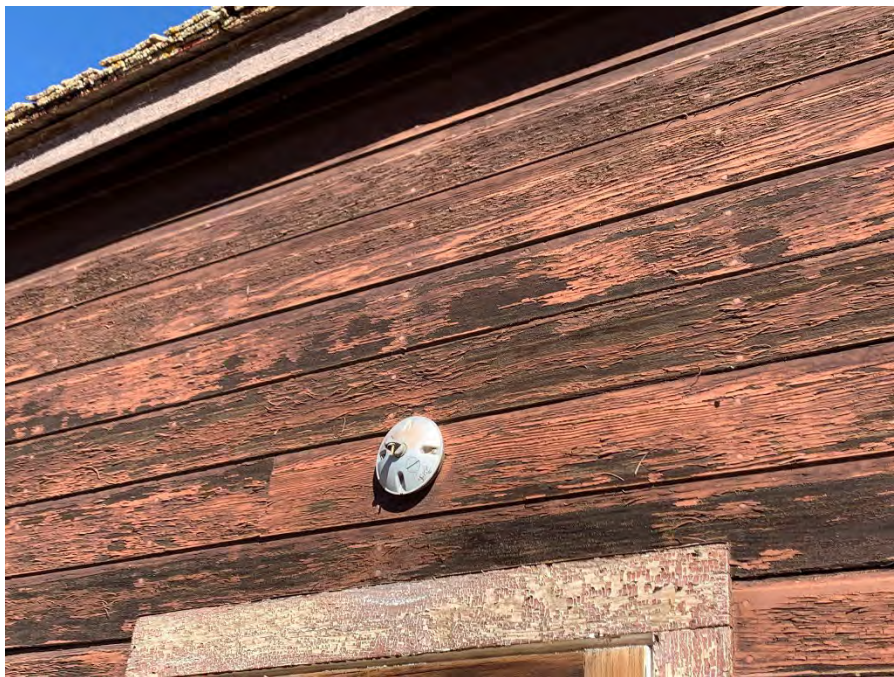
Figure 100: Light fixture location above the living room entrance on the west elevation.

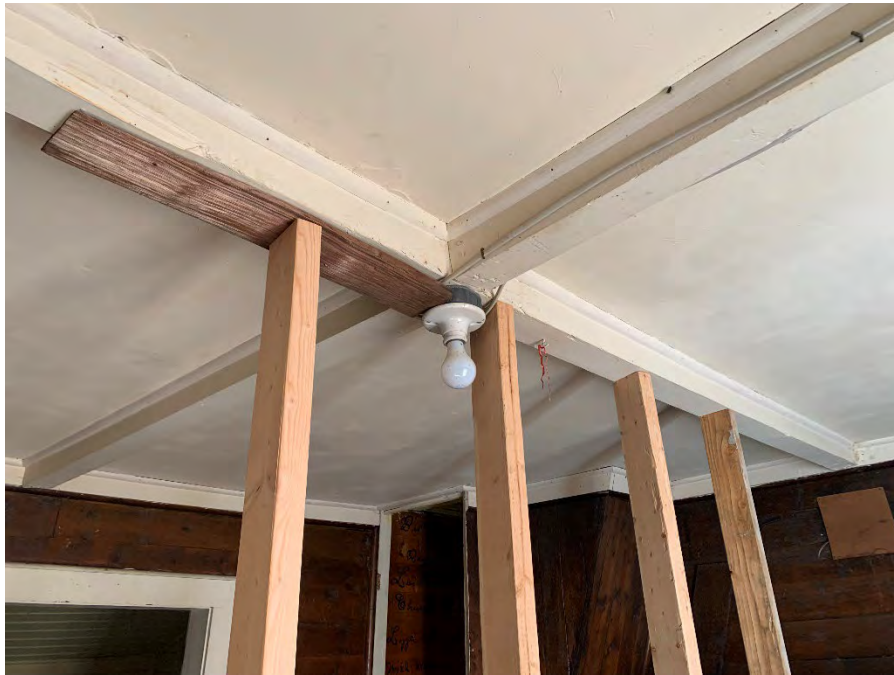
Figure 102: Light fixture located in the center of the living room ceiling.

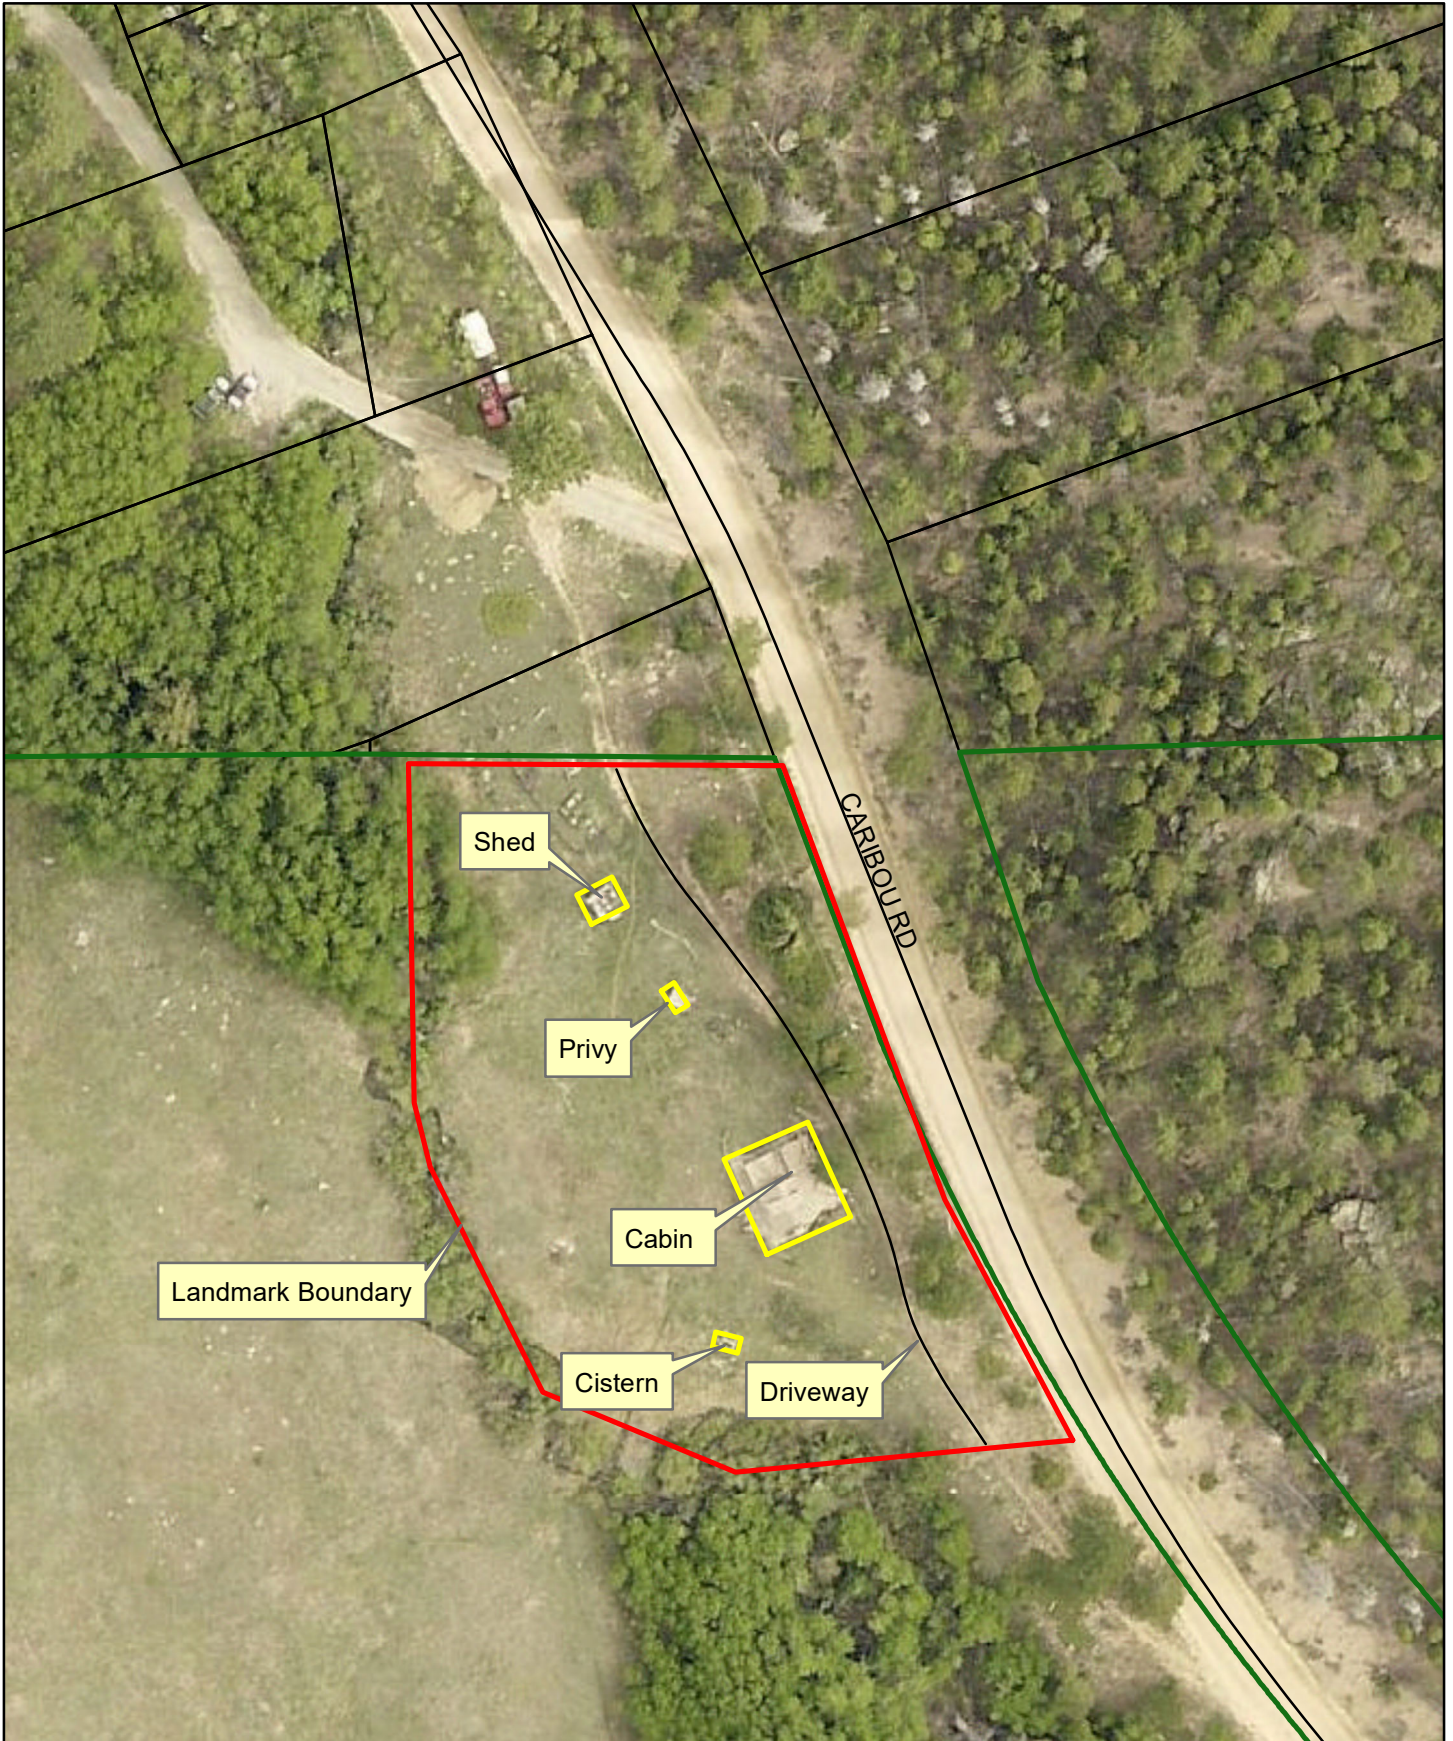
Preservation Activities	\$18,000
General Conditions	\$2,700
Overhead & Profit	\$1,800
Bonding & Permit	\$900
Consulting Fees (Construction Administration)	\$5,500
Archaeological Monitoring	\$1,750
Contingency	\$4,600
 ESTIMATED TOTAL	 \$35,250
