**MEETING OF THE HISTORIC PRESERVATION ADVISORY BOARD
BOULDER COUNTY, COLORADO
AGENDA**

6.1 HP-25-0001: Laber Farm

7.1 HPG-25-0002: Laber Farm - Structural Repairs on the House

Docket HPG-25-0002: Laber Farm – Structural Repairs

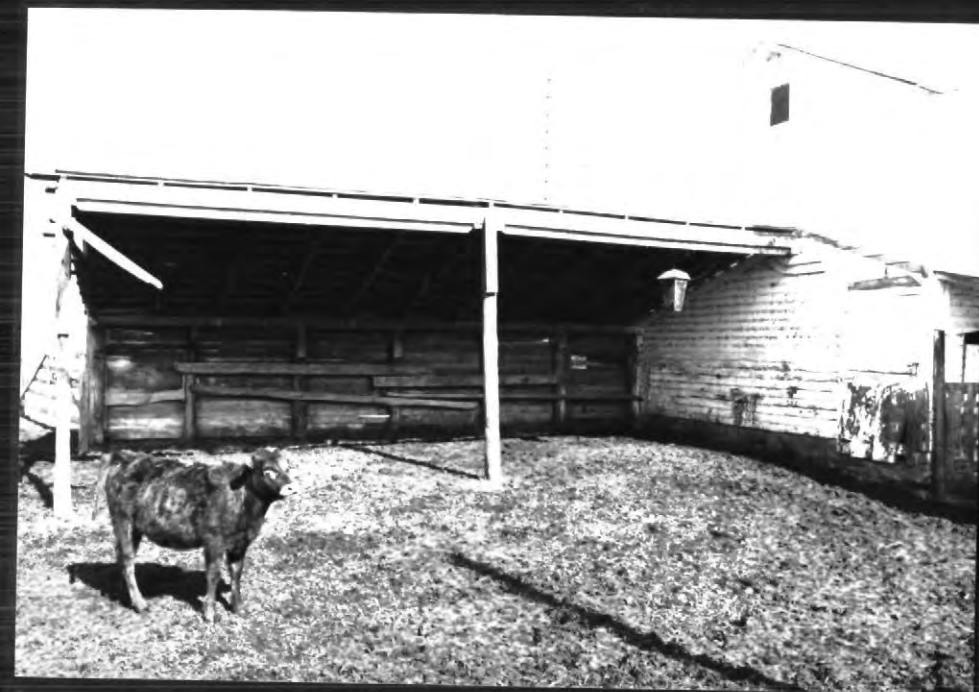
5BL6974 8003 North 95th Street
Barn
21 February 1998
Negative located at Boulder County Parks and Open Space Department
2045 13th Street, Boulder, CO 80306
Photographed by Carl McWilliams
Roll CM-91 Frame 9
View to NE

One-story rectangular plan; 80' N-S by 21' E-W, with a 24' by 29' addition built onto the north elevation; oriented to the east; low concrete perimeter walls foundation; earth floor; painted white board and batten exterior walls, over wood frame construction; saltbox roof with corrugated metal roofing material over 1x wood decking and 2x rafters; four open bays along the east elevation; horizontal sliding vertical wood plank door, located near the north end of the east elevation; two open bays enter the addition at the north end of the east elevation; fair condition.

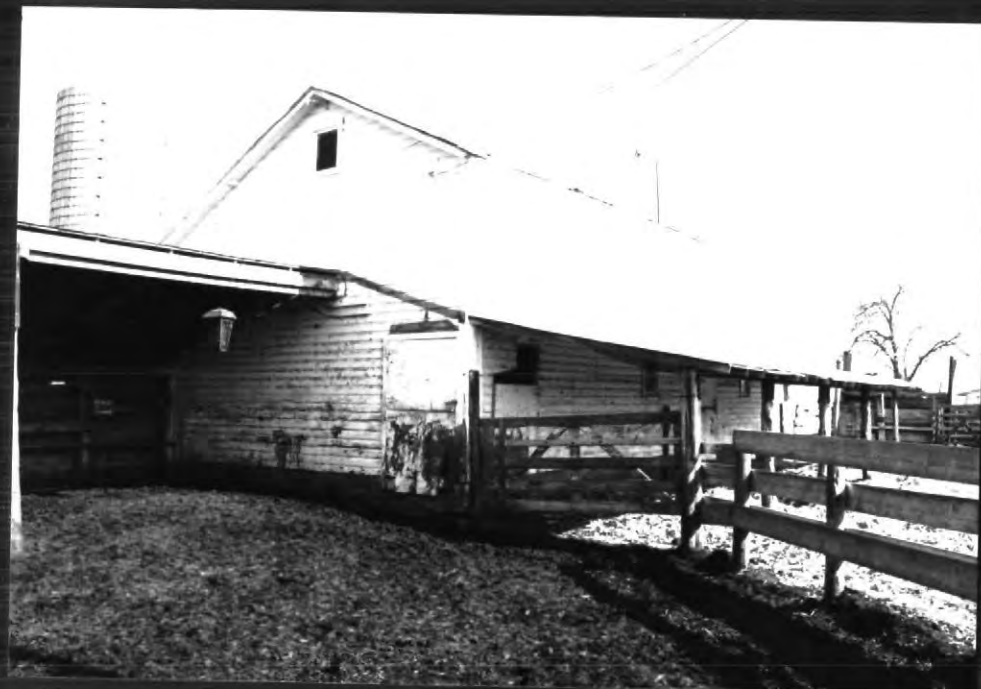
5BL6974 8003 North 95th Street
Loafing Shed
21 February 1998
Negative located at Boulder County Parks and Open Space Department
2045 13th Street, Boulder, CO 80306
Photographed by Carl McWilliams
Roll CM-91 Frame 10
View to NE

One-story rectangular plan, connected to the barn on the east elevation; 14' N-S by 32' E-W; horizontal wood plank walls, nailed to round posts set in the ground; earth floor; shed roof with corrugated metal over 1x wood decking and 2x rafters; south and west elevations are open; no additions; fair condition.

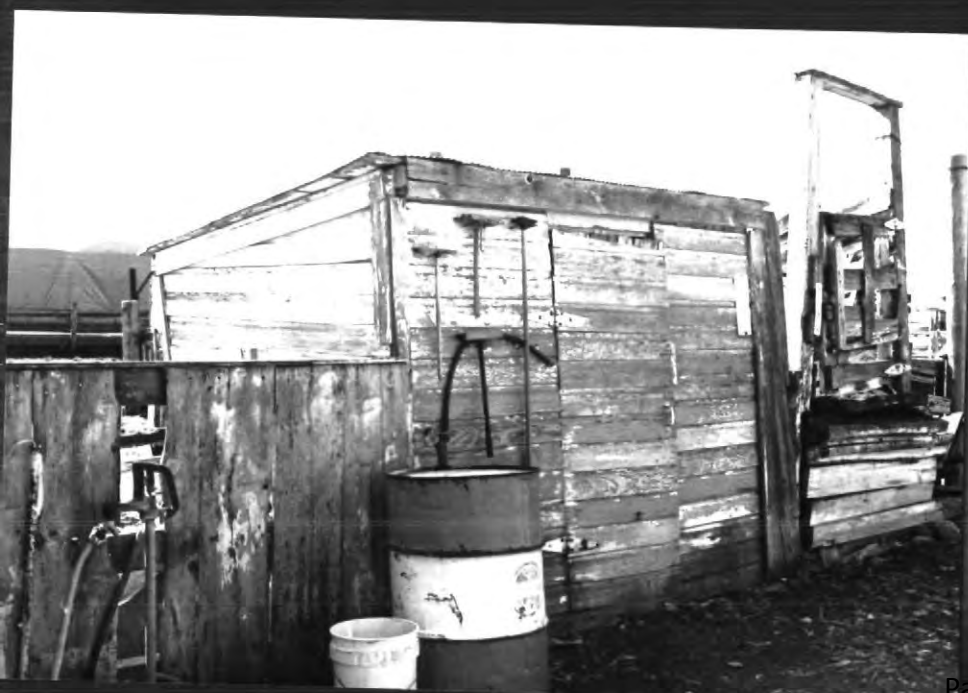
5BL6974 8003 North 95th Street
Pumphouse Shed for Stock Well
21 February 1998
Negative located at Boulder County Parks and Open Space Department
2045 13th Street, Boulder, CO 80306
Photographed by Carl McWilliams
Roll CM-91 Frame 11
View to SW

One-story rectangular plan; ~8' N-S by ~10' E-W; oriented to the east and west; poured concrete foundation; painted white horizontal weatherboard exterior walls; shed roof with corrugated metal over 1x wood decking; horizontal weatherboard door located on the east elevation; no additions or alterations; fair condition.

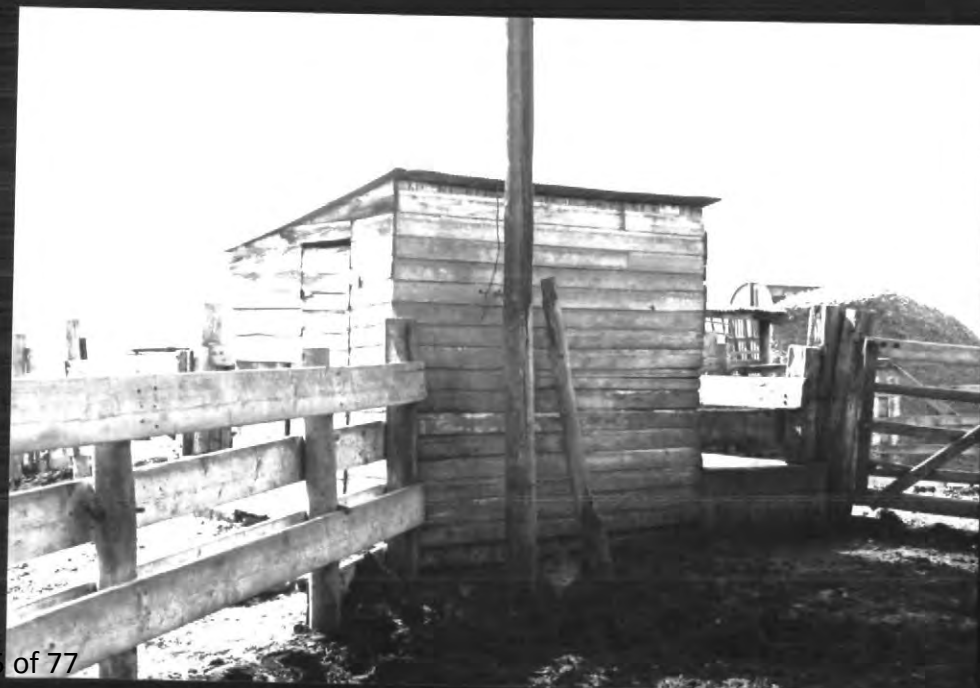
5BL6974 8003 North 95th Street
Oil Shed
21 February 1998
Negative located at Boulder County Parks and Open Space Department
2045 13th Street, Boulder, CO 80306
Photographed by Carl McWilliams
Roll CM-91 Frame 12
View to SW

One-story rectangular plan; 7' N-S by 8' E-W; oriented to the north; wood timbers on grade foundation; wood plank floor; painted white horizontal weatherboard exterior walls, with painted white 1" by 4" corner posts; shed roof with corrugated metal over 1x wood decking and 2x rafters; horizontal weatherboard door, side hinged with metal strap hinges, located on the north elevation; no additions or alterations; fair condition.

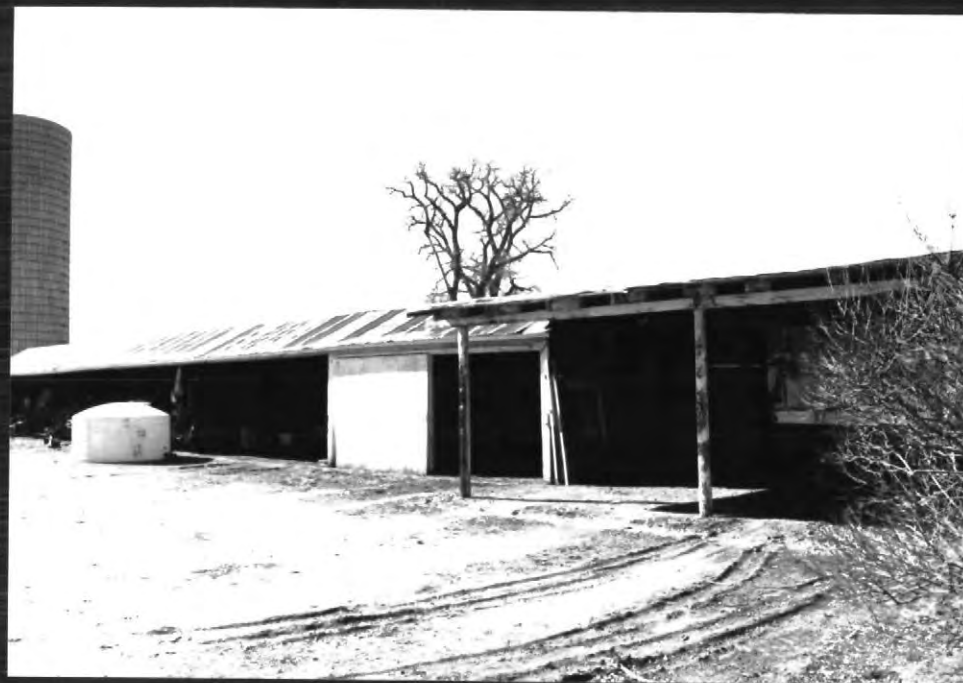
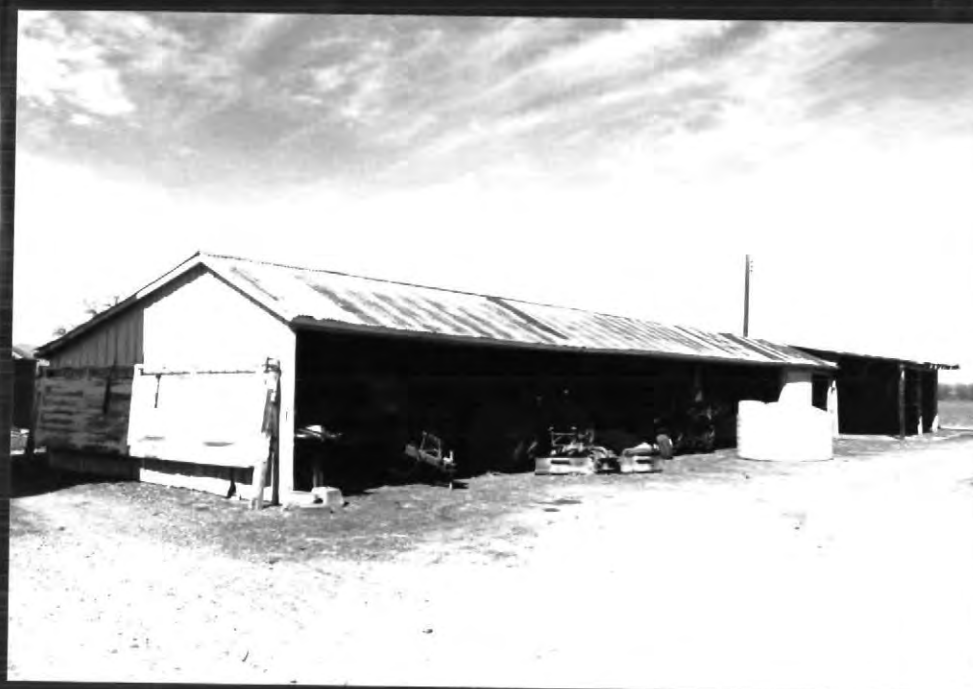
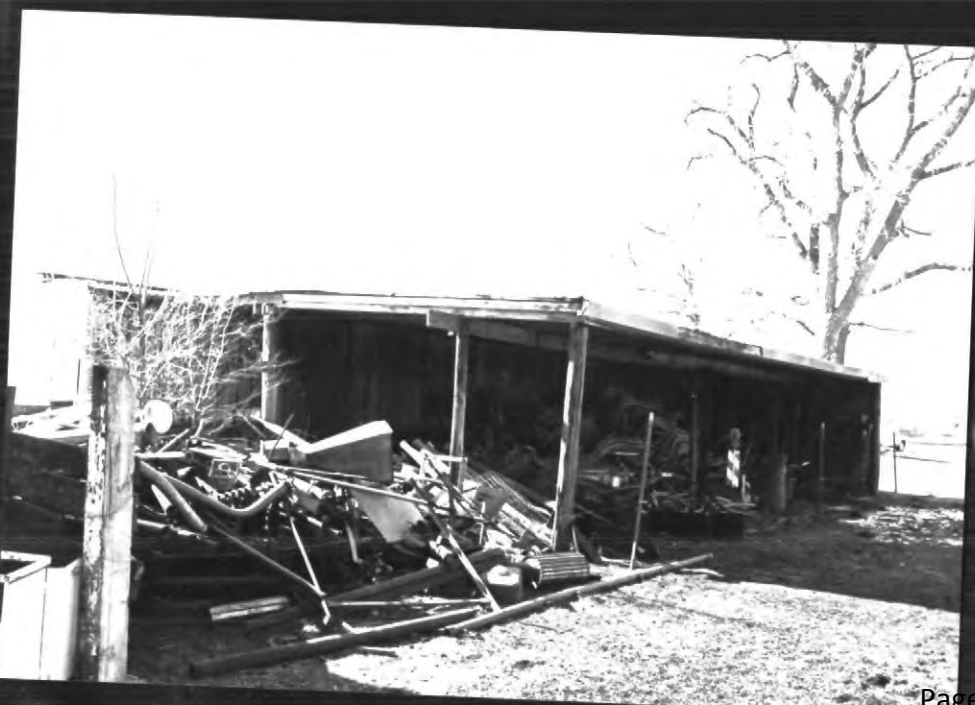
5BL6974 8003 North 95th Street
Old Machine Shed
21 February 1998
Negative located at Boulder County Parks and Open Space Department
2045 13th Street, Boulder, CO 80306
Photographed by Carl McWilliams
Roll CM-90 Frame 22
View to NW

One-story rectangular plan; 31' N-S by 46' E-W; oriented to the east; low concrete perimeter walls foundation; poured concrete floor in north half; earth floor in south half; painted white horizontal weatherboard exterior walls, with painted white 1" by 4" corner posts; saltbox roof with green asphalt shingles and exposed painted white rafter ends with fascia; one 4-light window on the upper gable end on the east elevation; one single-light window in the upper gable end on the west elevation; two sets of paired, painted white, vertical wood plank doors, side hinged with metal strap hinges, located on the east elevation; two, painted white, horizontal weatherboard doors, both side hinged with metal strap hinges, located on the north elevation; horizontal weatherboard dutch door, side hinged with metal strap hinges, located at the south end of the west elevation; no additions or alterations; fair condition.

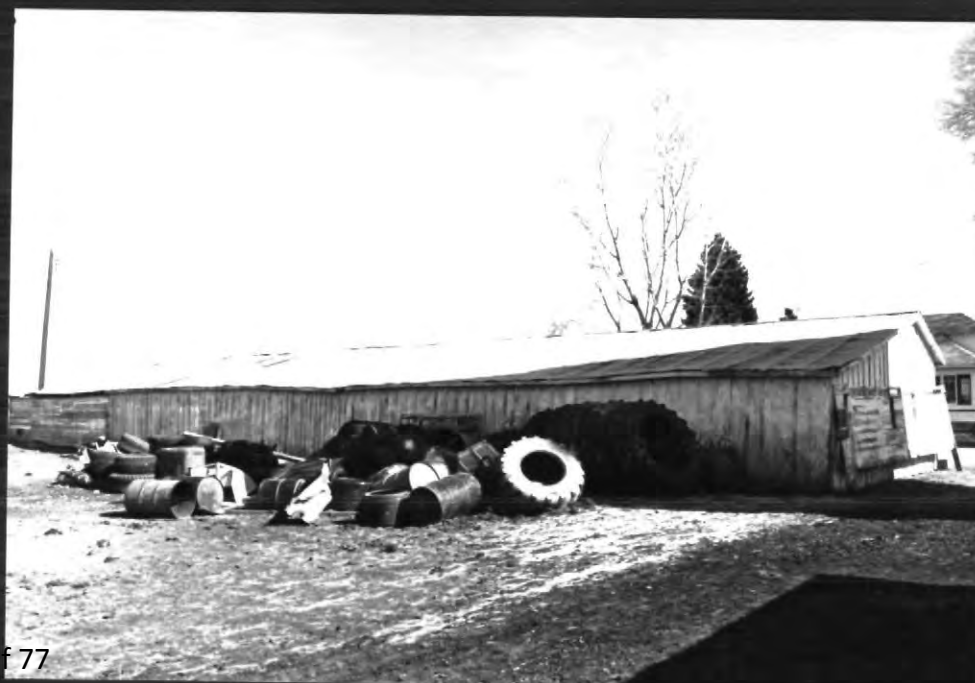
5BL6974 8003 North 95th Street
Hay / Storage Shed
21 February 1998
Negative located at Boulder County Parks and Open Space Department
2045 13th Street, Boulder, CO 80306
Photographed by Carl McWilliams
Roll CM-91 Frame 4
View to SW

One-story rectangular plan, connected to a railroad boxcar on the south elevation (the south wall of the boxcar serves as the north wall of this structure); 30' N-S by 42' E-W; painted white vertical wood plank walls, nailed to round posts set in the ground; earth floor; shed roof with corrugated metal over 1x wood decking and 2x rafters; east and north elevations are open; fair condition.

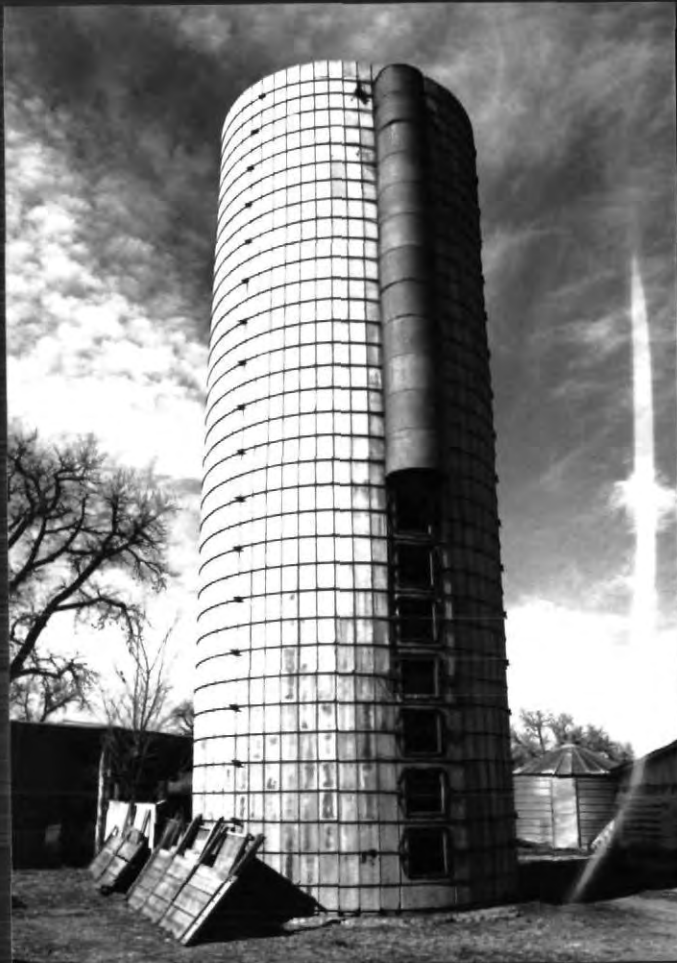
5BL6974 8003 North 95th Street
Metal Grain Bin
21 February 1998
Negative located at Boulder County Parks and Open Space Department
2045 13th Street, Boulder, CO 80306
Photographed by Carl McWilliams
Roll CM-90 Frame 25
View to NW

Oriented to the southeast; 45'-circumference; bolted corrugated metal construction; structures rest on wood plank foundations; metal doors facing southeast; conical roofs; the following inscription appears on the doors in raised block lettering:

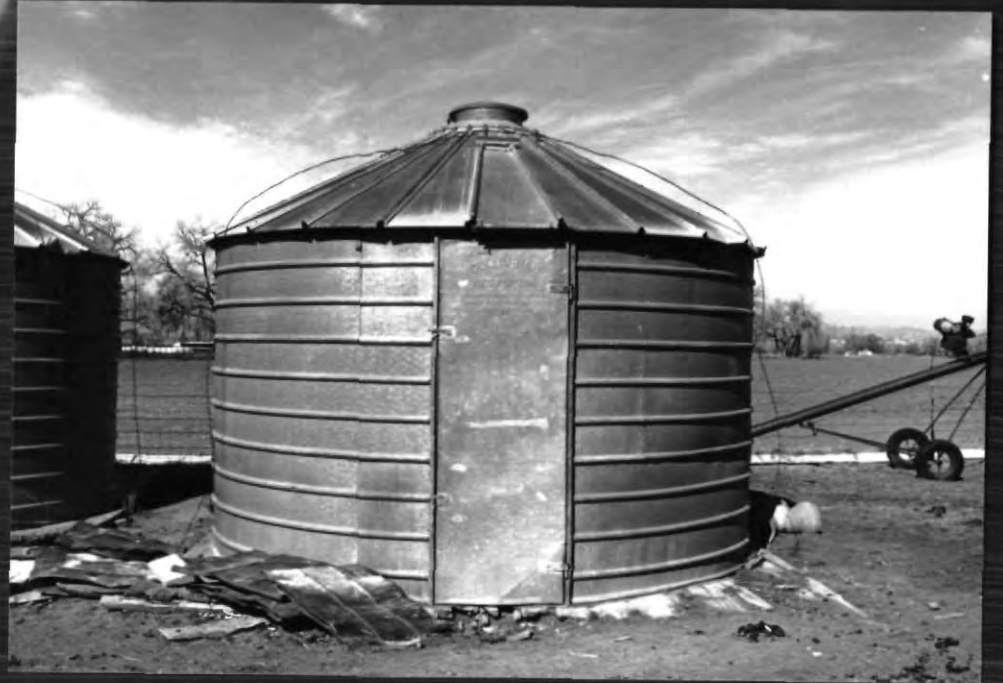
5BL6974 8003 North 95th Street
Silo
21 February 1998
Negative located at Boulder County Parks and Open Space Department
2045 13th Street, Boulder, CO 80306
Photographed by Carl McWilliams
Roll CM-91 Frame 3
View to NW

Not currently in use; 51' circumference; ~45' high; poured concrete foundation; earth floor; concrete stave walls, held together with steel strapping bolts; open roof; fair condition.

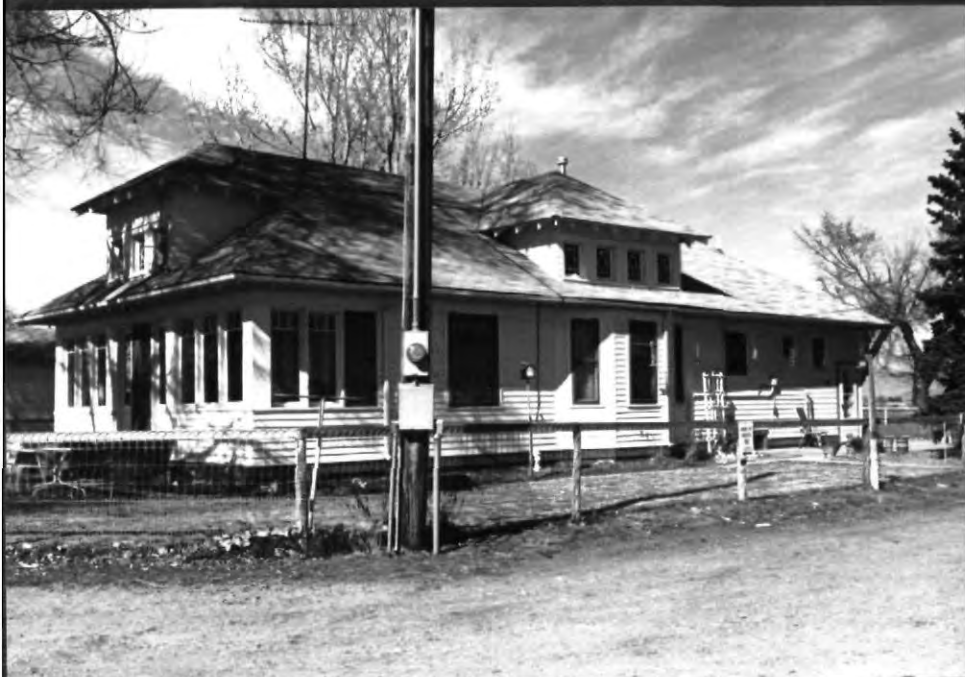
5BL6974 8003 North 95th Street
House
21 February 1998
Negative located at Boulder County Parks and Open Space Department
2045 13th Street, Boulder, CO 80306
Photographed by Carl McWilliams
Roll CM-90 Frame 14
View to North

Foundation: painted dark green poured concrete, partially covered with wood skirting; 1" by 2" wood watertable; partial basement with single-light hopper basement windows

Doors: painted white glass-in-wood-frame entry door, with a painted dark green wood screen door, at exterior of enclosed front porch on the south elevation; stained dark brown glass-in-wood-frame door leads from porch into interior of house; painted white wood-paneled door, with a white metal storm door, enters enclosed rear porch at the north end of the east elevation

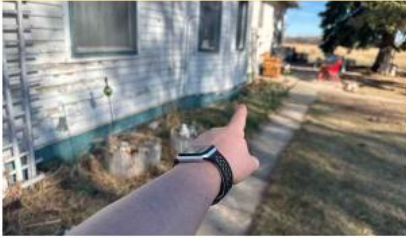
9.4.1 - Grading (within 6 feet of structure)

EXTERIOR - INSUFFICIENT DRAINAGE

The property had areas of neutral or negative drainage which will route runoff from precipitation to the foundation, which may cause moisture intrusion. Excessive moisture content in soil supporting the foundation can cause foundation and other structural damage from undermining, heaving or settling, depending on soil

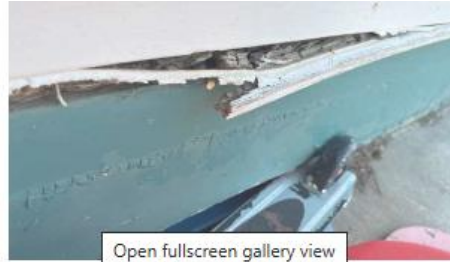
EXTERIOR - WOOD ROT

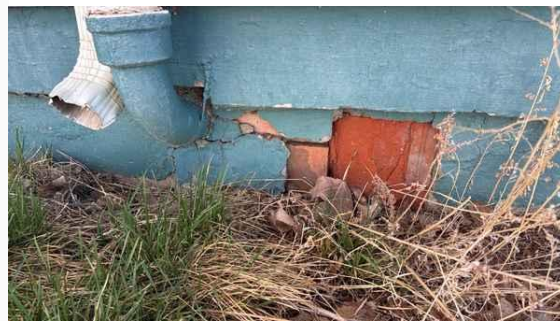
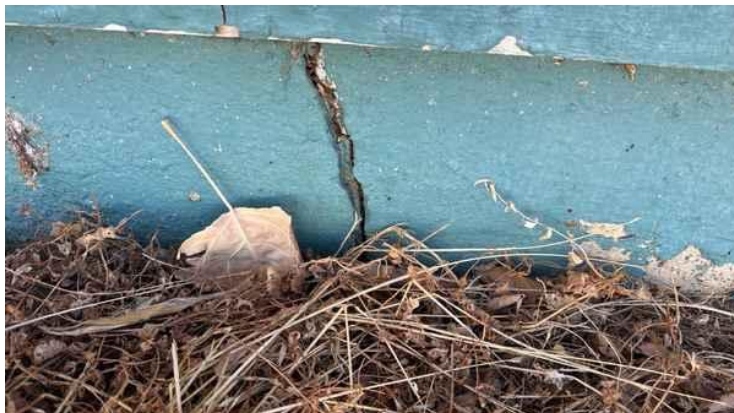
GUTTER DOWNSPOUT - 5 FEET, DOWNHILL SLOPE, UNDAMAGED

All of the gutter down spouts should have extensions that divert water at least 5 feet from the foundation of the structure. They should be secured to the downspout, undamaged and sloped downhill. This issue can potentially allow moisture intrusion.

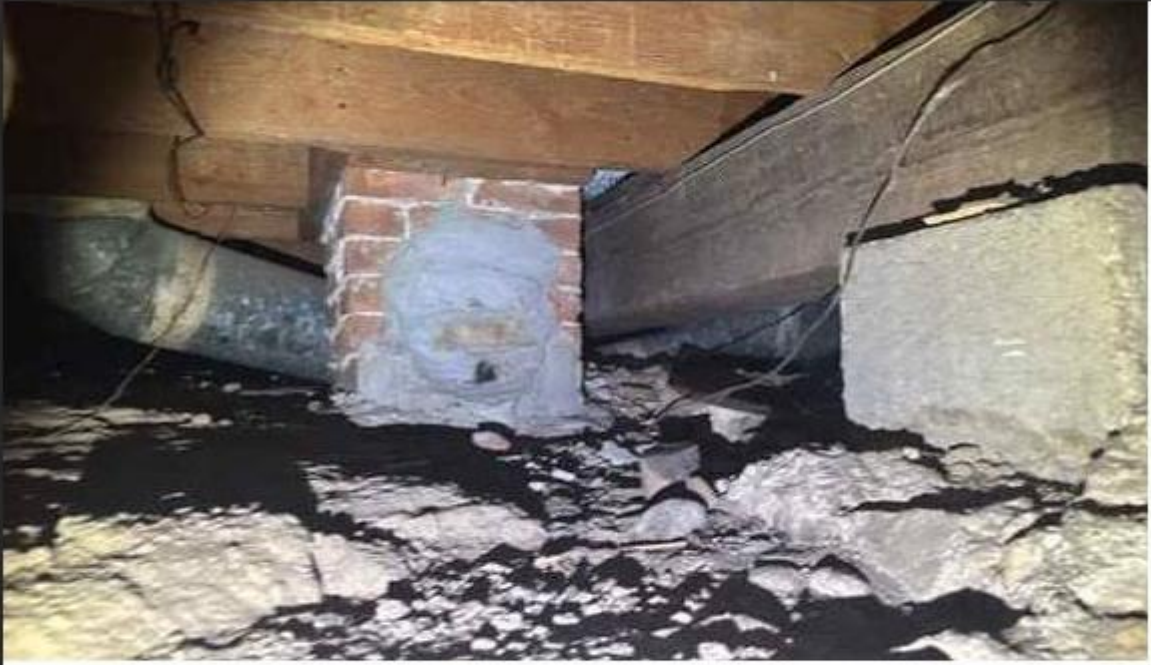
8003 North 95th Street

- The main N/S wood beam has some extensive checking (cracking).
- The main floor framing along the exterior perimeter of the crawl space sits on wood knee walls that sit on concrete footings with no visible connections between the sill plate and concrete footing.
- The exterior side of the knee wall is in contact with the soil. Some moisture damage (dry rot) is visible.
- The clearance between the soil and main floor framing is minimal.
- The roof gutter downspouts discharge too close to the foundation
- The soil is in contact with the siding at some locations.

Crawlspace photo. Items A, B and C. Foundation and house beams visible connections between the sill plate and concrete footing evidence not attached/secured.

Repair of the structural integrity of the foundation including the crawlspace and exterior perimeter between the rim joists and down along the foundation walls will be contracted with Groundworks of Denver CO. These repairs include floor sister floor joists throughout the crawlspace replacing deteriorated boards, attaching new lumber alongside existing framing to restore the structural integrity along the perimeter of the foundation. Additionally, exterior insulation and crawlspace encapsulation will be secured to protect against moisture and additional foundation damage.

Feature A	
<p>Name of Architectural Feature:</p> <hr/> <p>Crawlspace Framing Repairs</p> <p>Describe feature and its condition:</p> <ul style="list-style-type: none"> • The main N/S wood beam has some extensive checking (cracking). • The main floor framing along the exterior perimeter of the crawl space sits on wood knee walls that sit on concrete footings with no visible connections between the sill plate and concrete footing. <hr/>	<p>Describe proposed work on feature:</p> <p>Sister floor joists throughout the crawlspace as needed and remove and replace any deteriorated sill plates and band boards. This process involves reinforcing weakened or damaged joists by attaching new lumber alongside the existing framing. The sill plate and band board are replaced where necessary to restore structural integrity along the perimeter of the foundation.</p>
Feature B	
<p>Name of Architectural Feature:</p> <hr/> <p>Exterior Insulation Installation</p> <p>Describe feature and its condition:</p> <p>The exterior side of the knee wall is in contact with the soil. Some moisture damage (dry rot) is visible. The clearance between the soil and main floor framing is minimal.</p> <hr/>	<p>Describe proposed work on feature:</p> <p>Installation of ExtremeBloc rigid foam board insulation to help prevent future moisture and air infiltration</p>

<p>Name of Architectural Feature:</p> <p>Crawlspace Encapsulation</p> <p>Describe feature and its condition:</p> <p>Protection against future moisture</p>	<p>Describe proposed work on feature:</p> <p>Install a 20 millimeter liner to extend at least 1 foot up the foundation wall for barrier against moisture.</p>
--	---
