### HISTORIC PRESERVATION ADVISORY BOARD

**Docket HP-26-0002: Amendment to Shannon Farm**

Request: Amendment to the Shannon Farm landmark

Location: 1341 N 95th Street, in Section 32, T1N, R69W of the 6th Principal Meridian

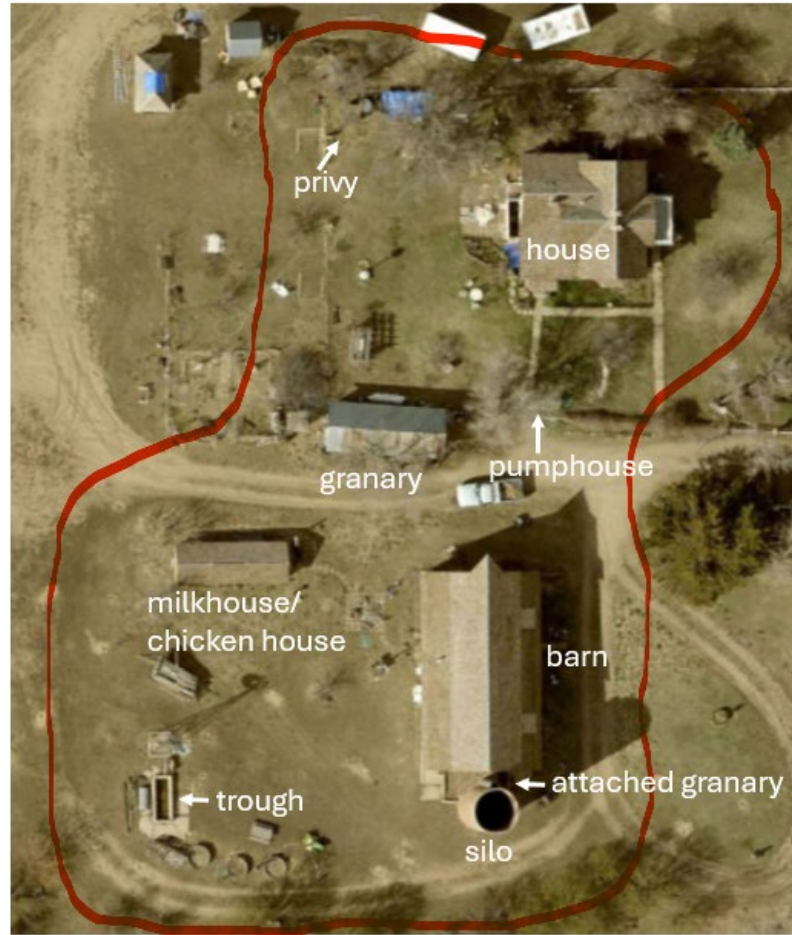
Rough shape of landmark boundary, an area with a 20-foot buffer enveloping all contributing resources.

The owners wish to amend the county landmark by landmarking a site that will envelop all of the contributing resources with a 20-foot buffer, and adding the granary, the pumphouse, the trough, and the privy as contributing resources. Their request does not include the irrigation ditch.

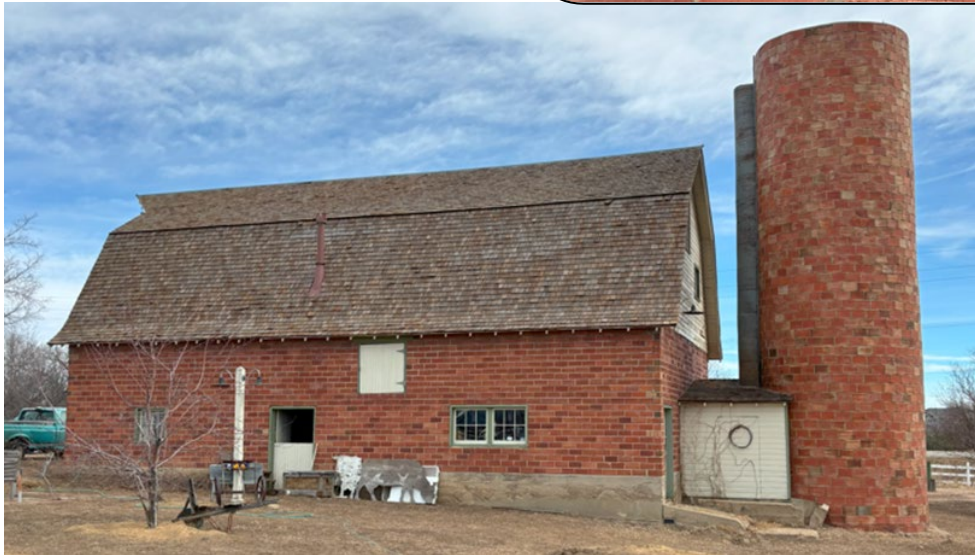
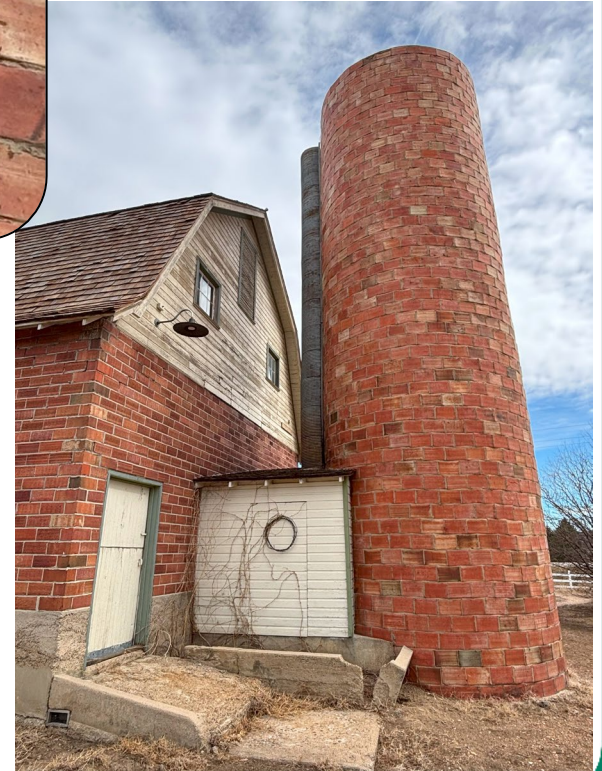
← handprints on  
handmade blocks

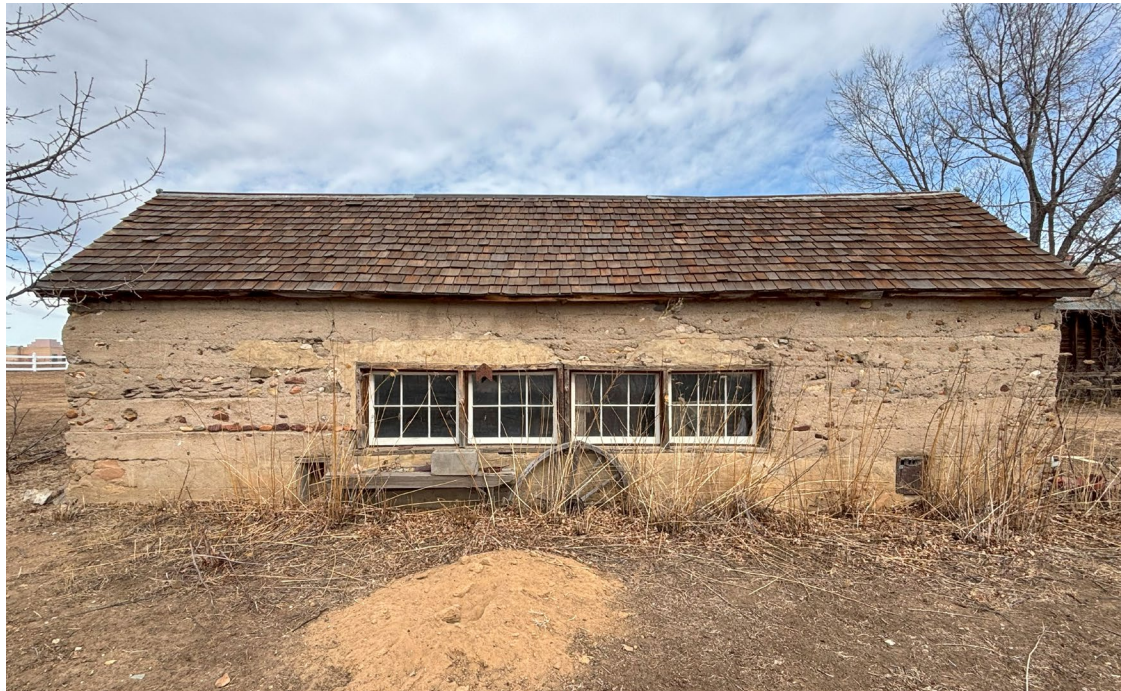
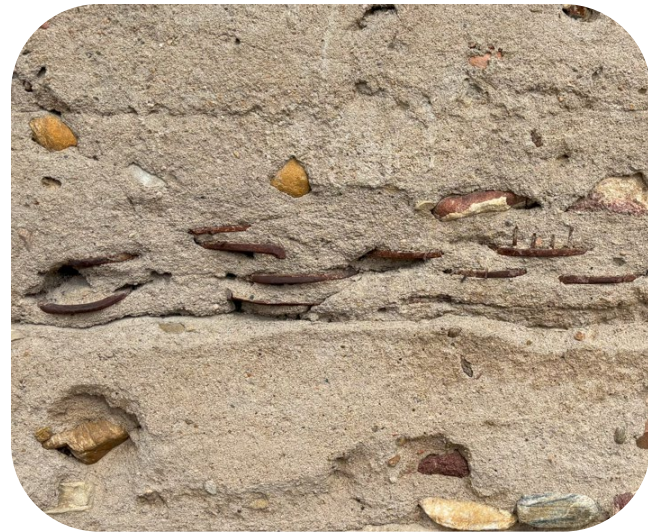
## Milkhouse/ chicken house

horseshoes and nails  
as binders

Also west of the barn is a one-story grout (lime and sand) chicken house/milk house. The rectangular plan building faces east with a gable roof running east/west. The east elevation has an off center tongue and groove door. The north and west elevations have solid grout walls. The south elevation contains two tiny doors at ground level. The west door is original; the east door appears to have been added later. Four 3/3 divided light windows were replicated to replace the missing windows on the south side. The lime-sand grout walls are in good condition on the north, east and west with some weathering on the corners. The south wall, however, was badly deteriorated around the windows. This area was restored using a similar mix of sand and grout after mortar analysis was done. Part of the wall on the southwest corner has weathered away to expose edges of horseshoes placed in courses as fill in the grout wall. The wall was poured in board forms with rock placed in courses and the grout mixture poured around the rock. Inside, a frame wall and door divide the west half of the building from the east half. The west section was used as a chicken house. Around 1918, the east half was converted to use as a milk house by adding a built-in brick milk can cooling trough. New wood shingles and a tin ridge cover the building. Ball finials sit atop the gable peaks.

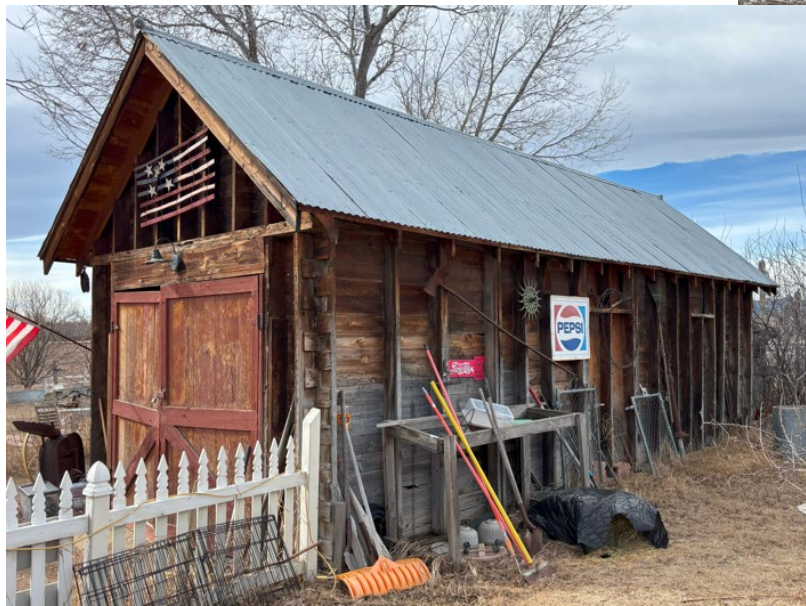
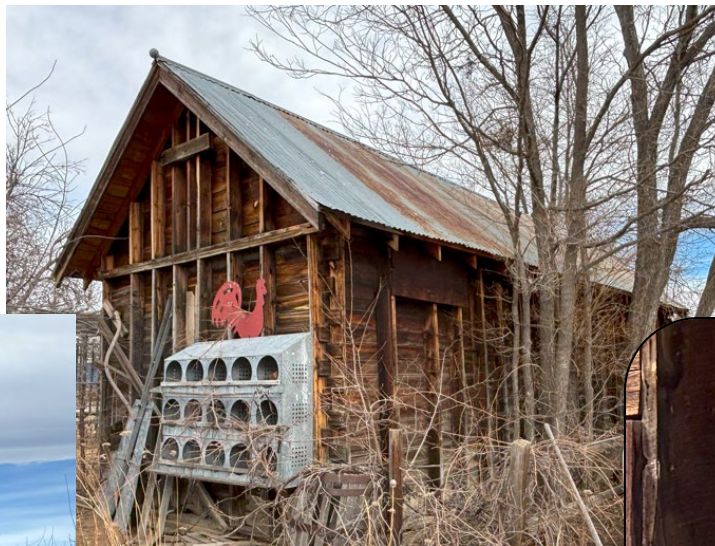
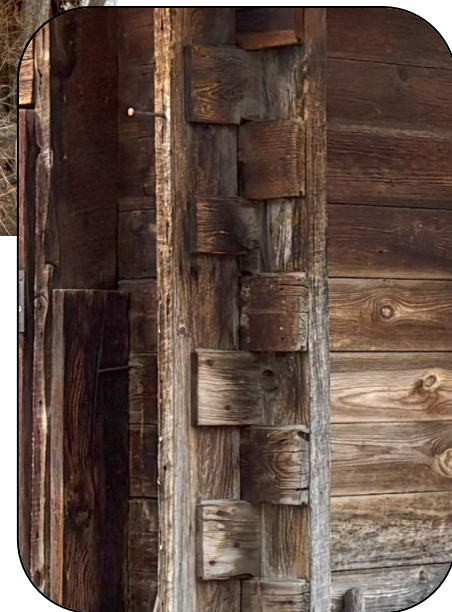
Granary/  
garage

interlocking  
siding →

A wood frame garage/granary is located at the south of the backyard. The building sits on a concrete slab. The 2x4 wall framing is exposed: the tongue-and-groove siding attached horizontally to the inside of the framing. The siding interlocks at the four corners. The granary was converted to use as a garage by adding two recycled doors in the east wall of the building at an unknown date. Tenants altered the roof of the granary/garage as well. The roof was reconstructed with the help of a 1941 photograph showing the original gabled roof. The gable ends were sided with old material found on-site and the original tin roofing material was reused on the most visible side of the building. Matching new tin roofing and a new tin ridge complete the roof.

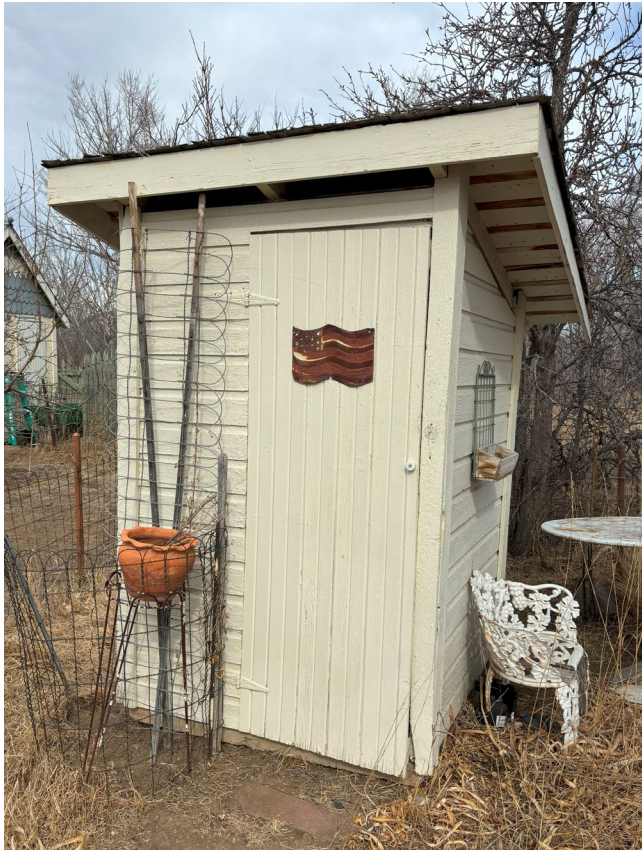
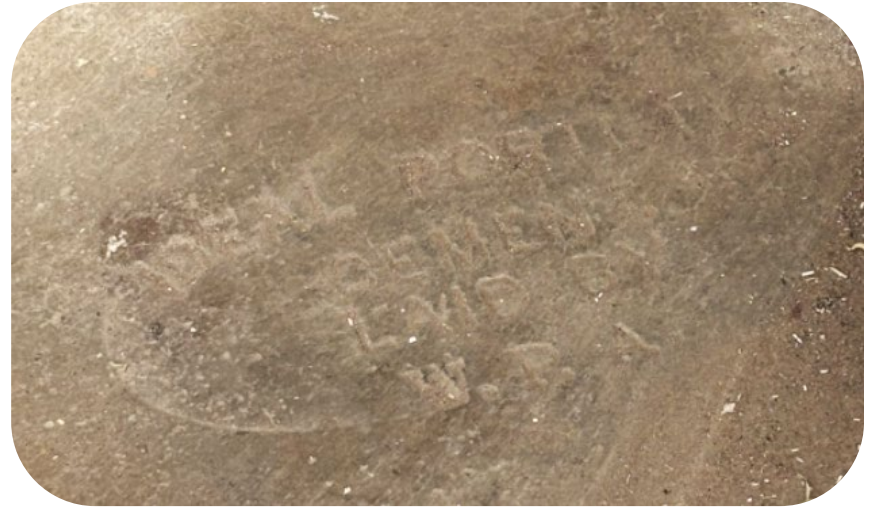
Privy

IDEAL PORTLAND  
CEMENT  
LAID BY  
W.P.A.
